POSTEARTHQUAKE REPAIR OF PRECAST CONCRETE
COLUMN-TO-FOOTING PLASTIC HINGES

Dylan Neil Brown

A thesis submitted to the faculty of
The University of Utah
in partial fulfillment of the requirements for the degree of

August 2014

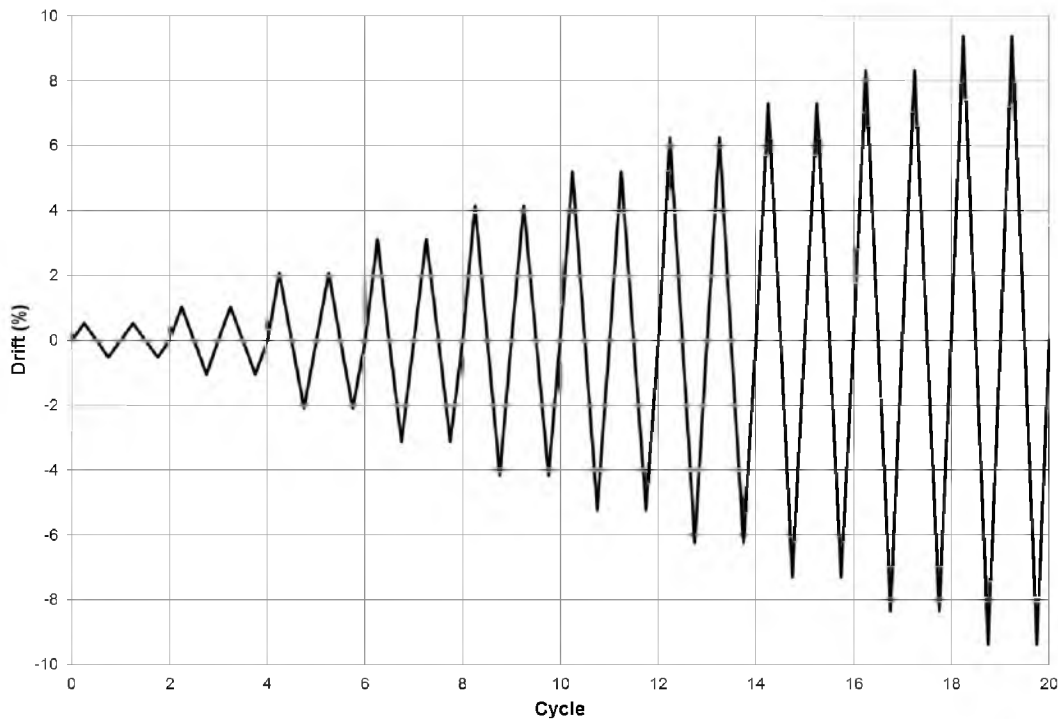
Figure 2.8 - Applied lateral displacement history

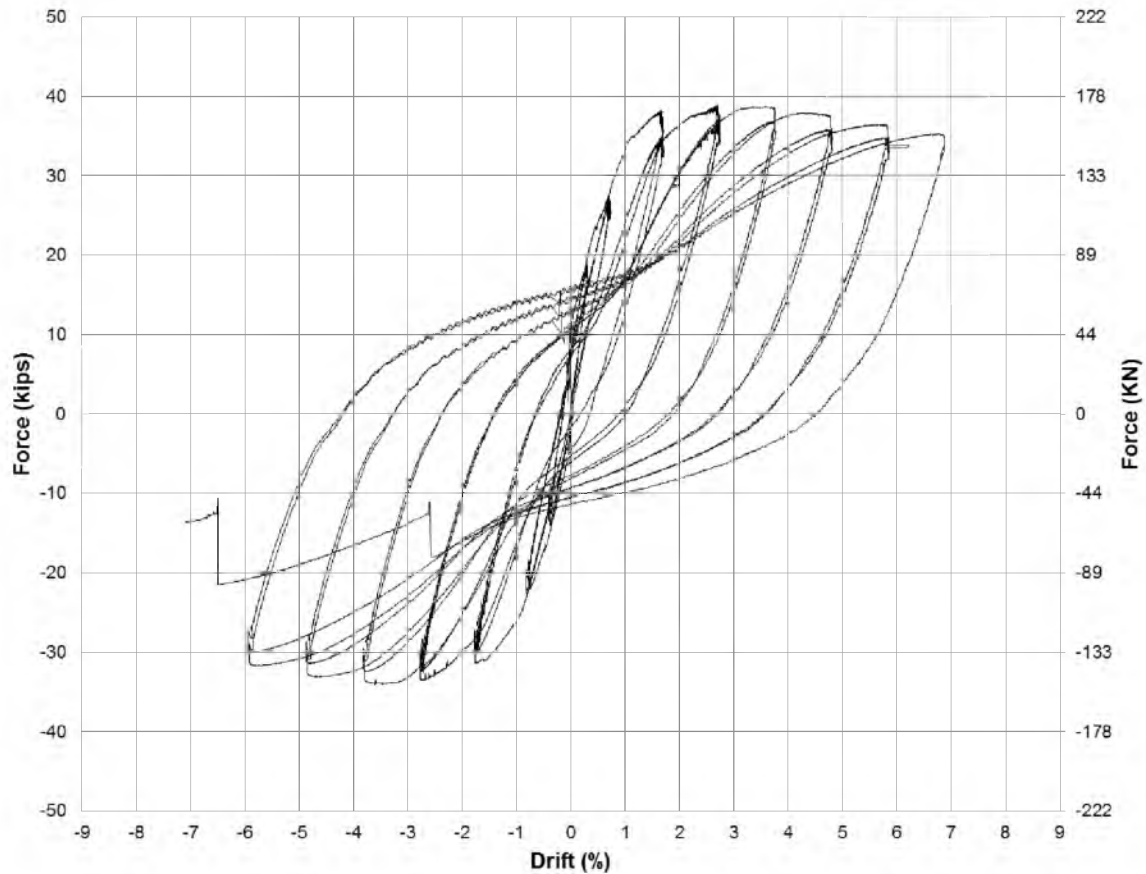
Figure 2.9 – NMB-2 hysteresis curve

capacity in the west direction, after the longitudinal rebar fractured, dropped to 65% of the ultimate lateral load capacity in that direction. The 7-in. displacement step was never completed due to a weld failing that secured the south axial load rod to the base plate of the axial load assembly.

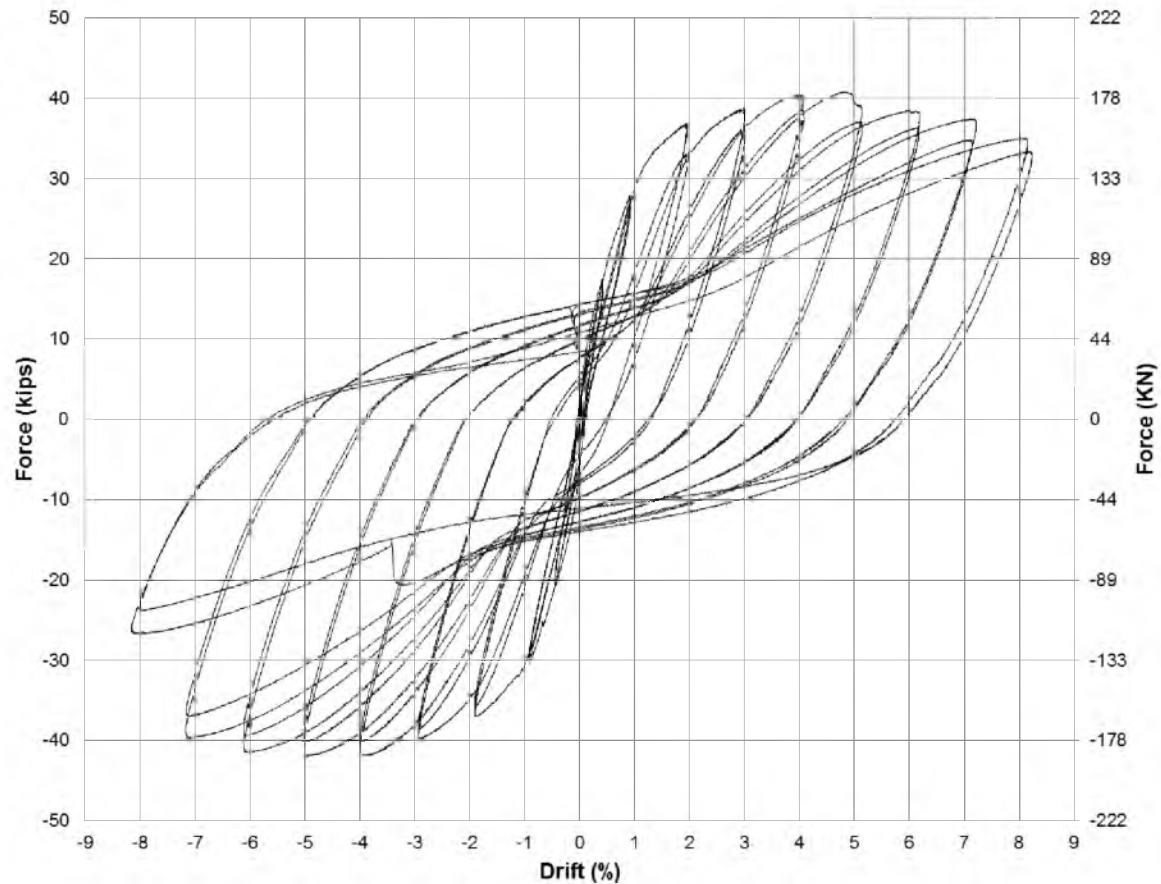
Figure 2.11 - NMB-3 hysteresis curve

step. The east extreme longitudinal rebar ruptured at the column-footing interface during the first cycle of the 8-in. displacement step. The lateral load capacity of the specimen when tested to the west was severely diminished after the longitudinal rebar fractured. The lateral load capacity in the west direction after the fracture dropped to 63% of the ultimate lateral load capacity. The damage state of NMB-3 during the final displacement step and after testing can be seen in Figure 2.12. A plastic hinge was evident at the column-footing interface with spalling extending up the column 12–16 in. on the west and east extreme column faces. However, there was noticeably less damage at the column-to-footing interface than during the NMB-2 test, indicating that the plasticity was forced into the footing due to the debonded bars. Structural cracking of the column occurred at two levels located approximately 14 in. and 23 in. above the footing. The maximum crack widths, measured during the pause between displacement steps, were 0.020 in. and 0.007 in. for the 14 in. and 23 in. crack levels, respectively.

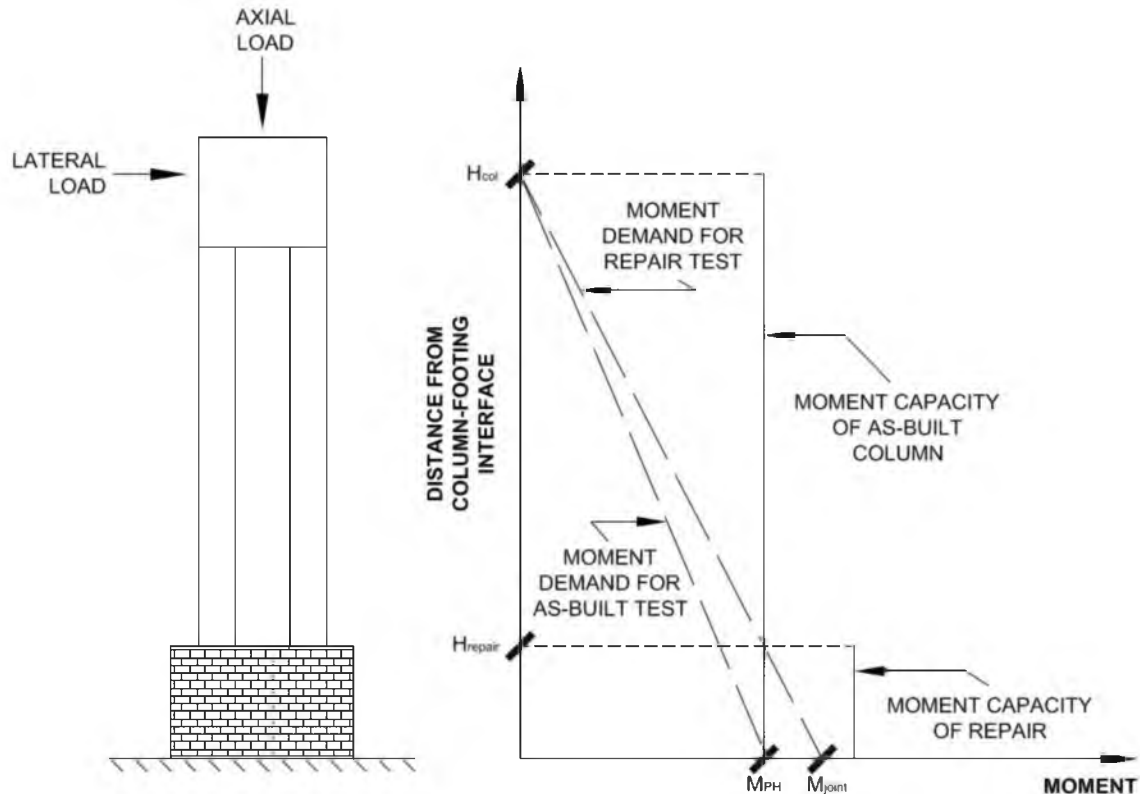
From both eq. 3.1 and 3.3 it can be seen that the repair height should be kept to a minimum to reduce the moment demand on the repair and the shear demand on the column. The shear capacity of the repaired cross-section will be much higher than the shear capacity of the as-built column. Since the shear demand is constant along the height of the column, it is likely that the shear capacity will be controlled by the as-built column shear capacity. Unless

Figure 3.1 – Graphical representation of design loads for simplified design procedure

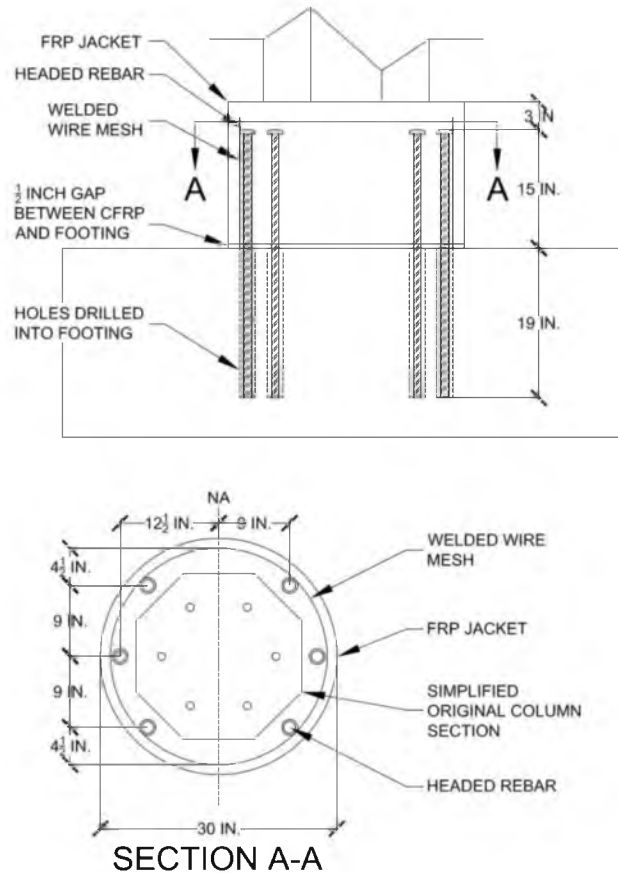
Placement of the headed rebar fixes the moment arm of each rebar and should be determined from several design criteria. First, a clear spacing of 2 in. between the as-built column and the center of the headed rebar should be maintained to allow space for drilling into the footing. Space should also be provided between the headed rebar and the CFRP wrap to

Figure 3.2 – Repair design details

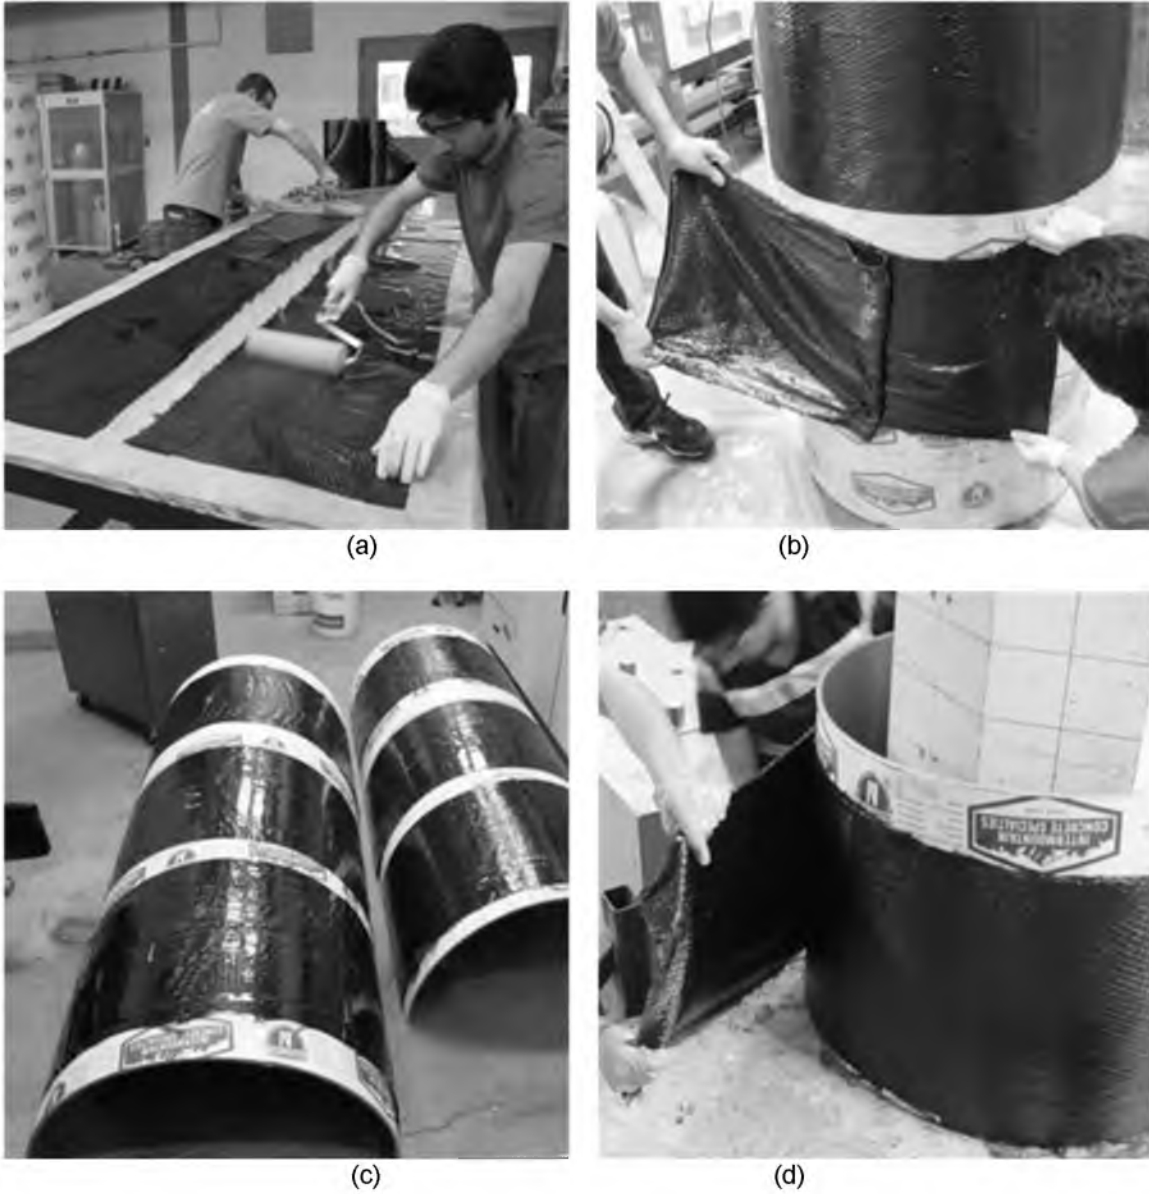
Figure 3.3 – CFRP preparation: (a) Saturation, (b) Making of prefabricated shells, (c) Prefabricated shells split into two, (d) Wet layup

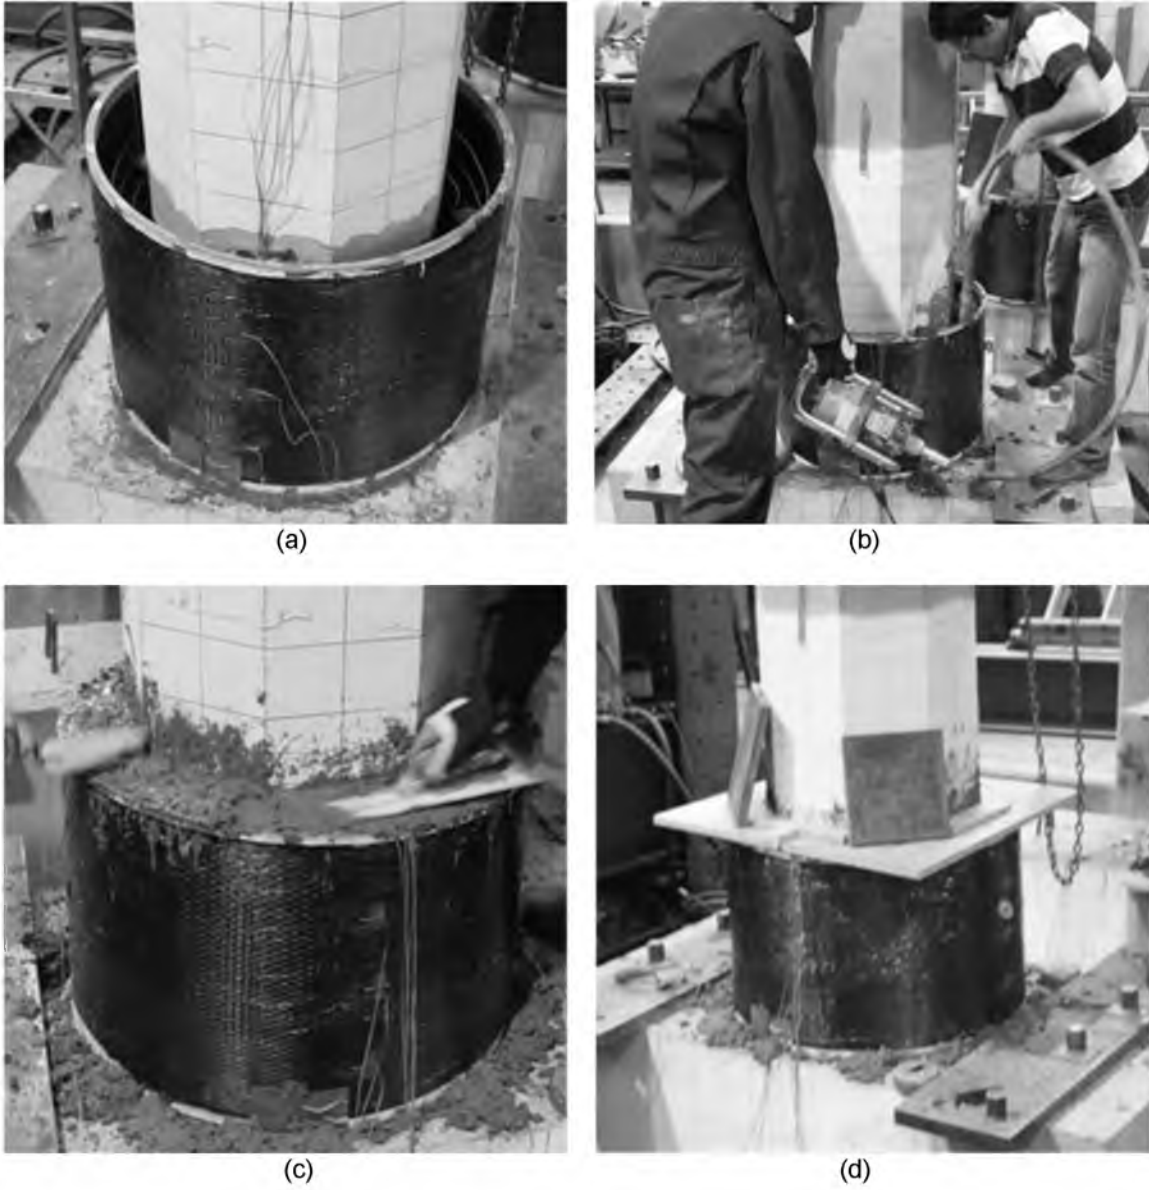
Once the CFRP shell and epoxy for the headed rebar had fully cured, nonshrink/expansive concrete was added to the space between the column and CFRP shell. The concrete was vibrated to minimize the amount of air voids left within the repair concrete. A 0.5-in. tall cylindrical piece of sonotube was secured under the CFRP shell to maintain the 0.5-in. gap between the CFRP shell and the footing. The piece of sonotube also ensured that the CFRP shell remained centered around the column. Wooden formwork was placed on the top of the CFRP shell to enclose the concrete within the repair. Weights were then placed on top of the formwork to keep the concrete from expanding vertically. The repair concrete was cured for at least 28 days before testing. Figure 3.5 shows the steps involved in casting the concrete for the repair process.

Figure 3.5 – Repair concrete casting: (a) Before casting, (b) Vibrating concrete during casting, (c) Finishing concrete after casting, (d) Wooden formwork and weights in place after casting

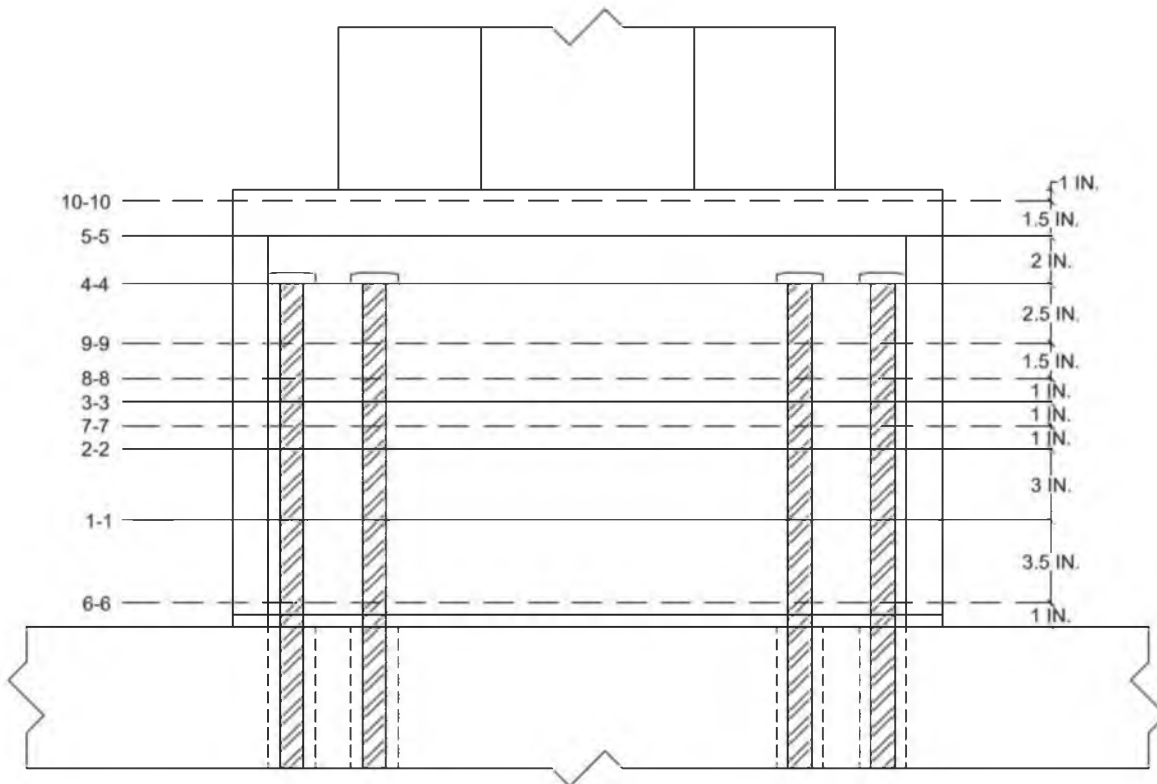
Figure 3.6 shows the strain gauge sections that were present for the NMB-2 Repair and NMB-3 Repair test. NMB-3 Repair had more strain gauges on both the wrap and headed rebar. Due to geometrical conflicts the exact locations of strain gauges did not always fall onto the designated section. This variation in placement is recorded in the naming scheme that has been adopted, which gives the strain gauge number entered into the data acquisition system followed by the height above the column footing interface in parentheses. The strain gauge schedules can be seen in Figures 3.7 and 3.8 for NMB-2 Repair and NMB-3 Repair, respectively.

Figure 3.6 - Strain gauge sections for NMB-2 Repair and NMB-3 Repair

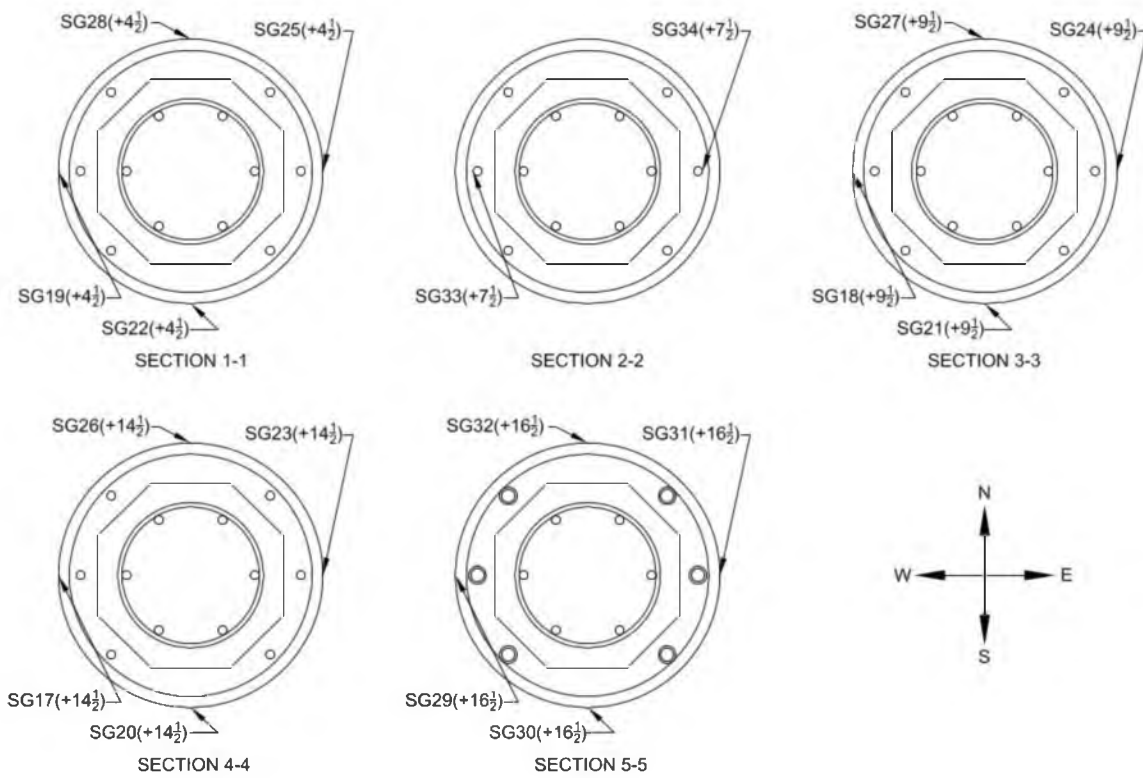
Figure 3.7 - Strain gauge locations for NMB-2 Repair

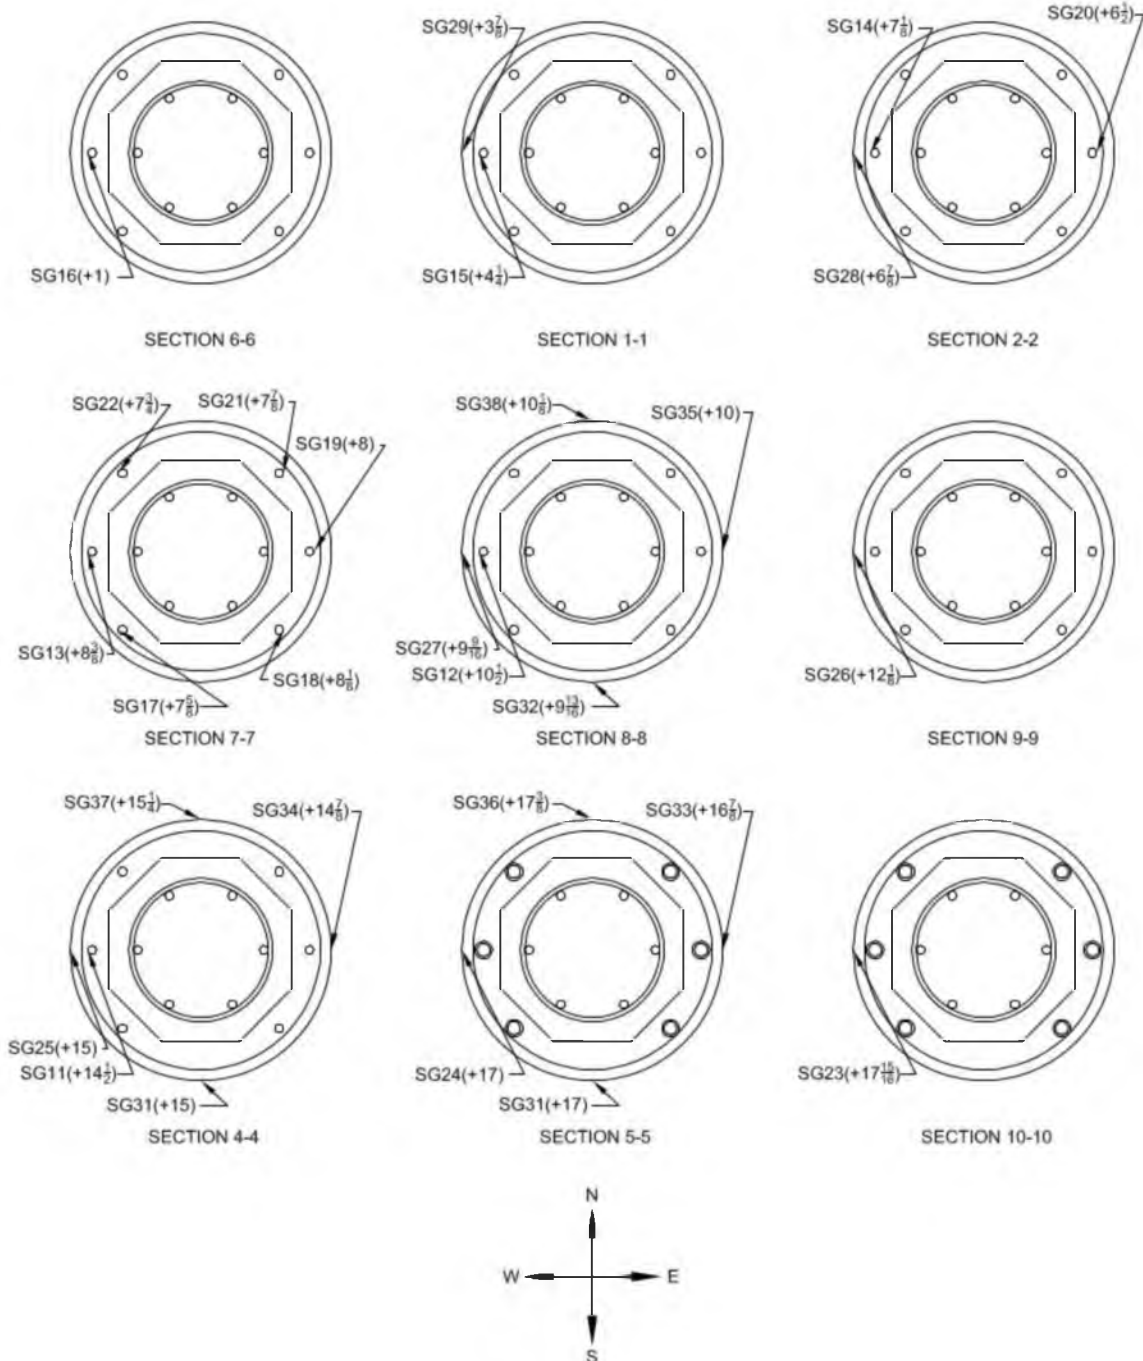
Figure 3.8 - Strain gauge locations for NMB-3 Repair

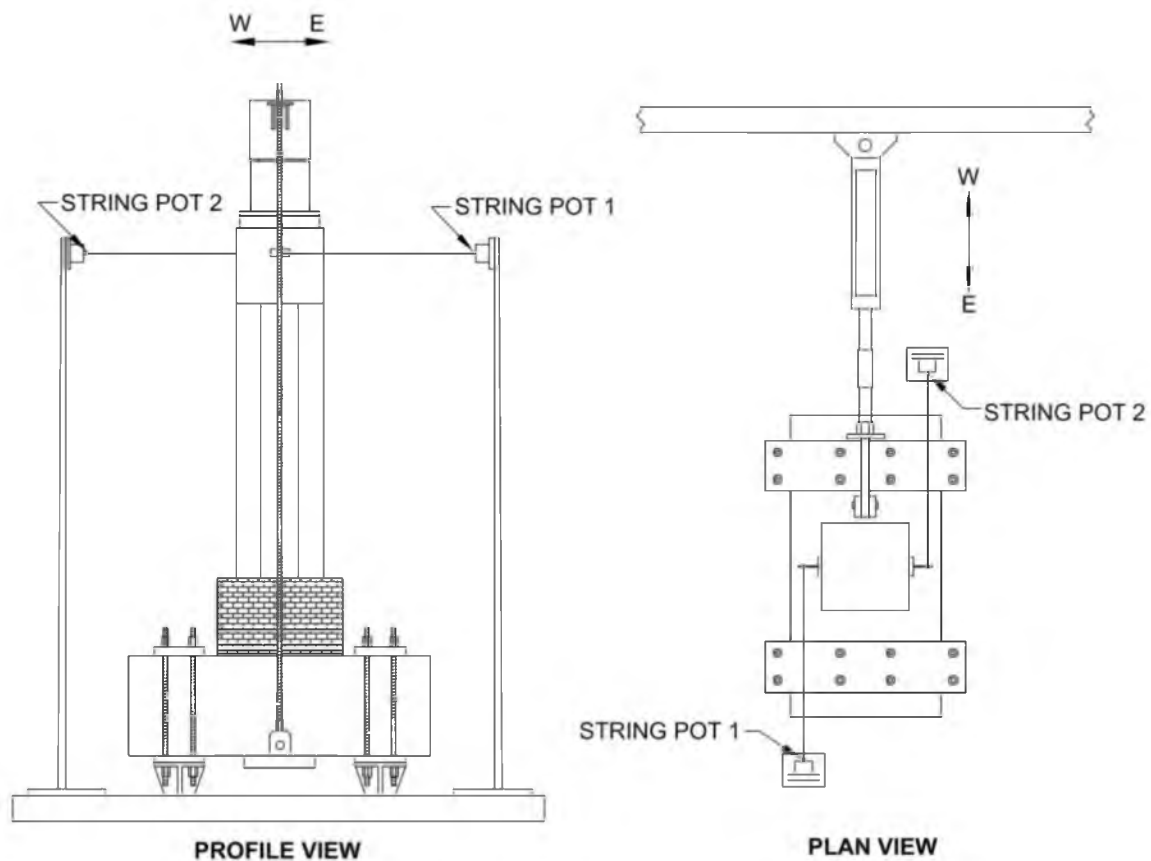
Figure 3.11 – String pot layout

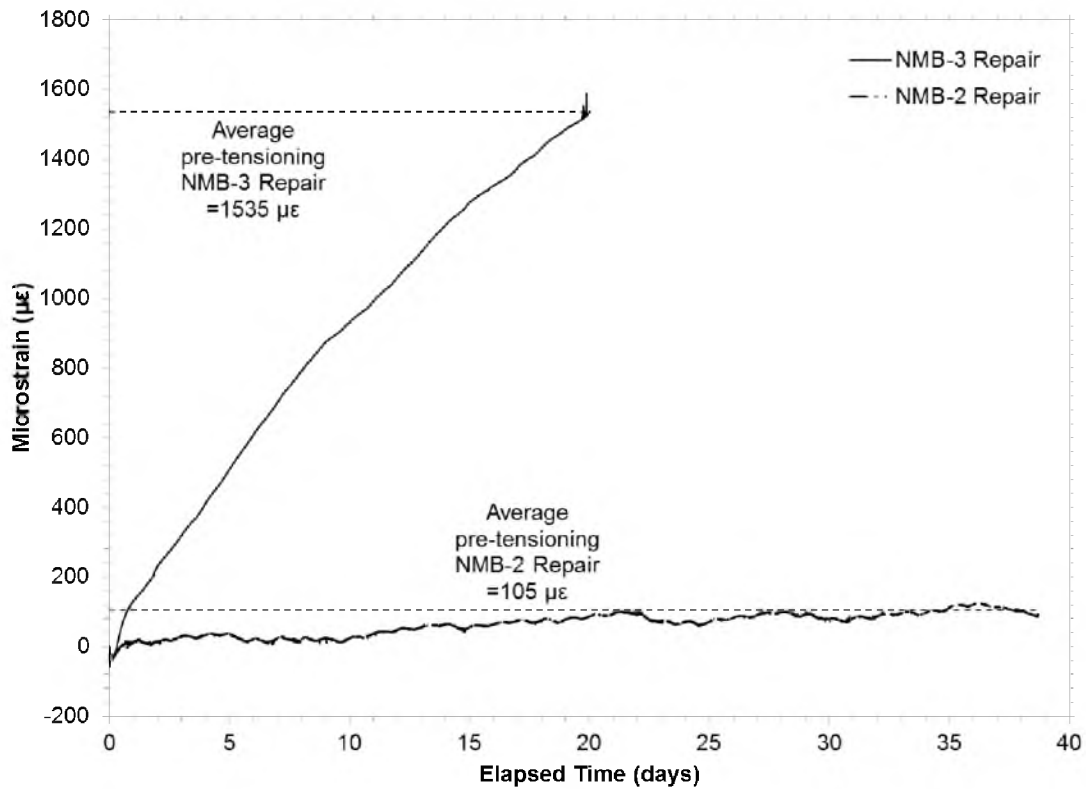
From this data, an average pre-tensioning value of the CFRP jacket 1 day prior to testing was determined. The average pre-tensioning prior to testing is 105 microstrain for NMB-2 Repair and 1535 microstrain for NMB-3 Repair. These pre-tensioning values account for 1% of the strain capacity of the CFRP jacket for NMB-2 Repair and 14% of the strain capacity of the CFRP jacket for NMB-3 Repair. Prior to testing, the data acquisition system was zeroed, and

Figure 4.1 – CFRP pre-tensioning for NMB-2 Repair and NMB-3 Repair prior to testing

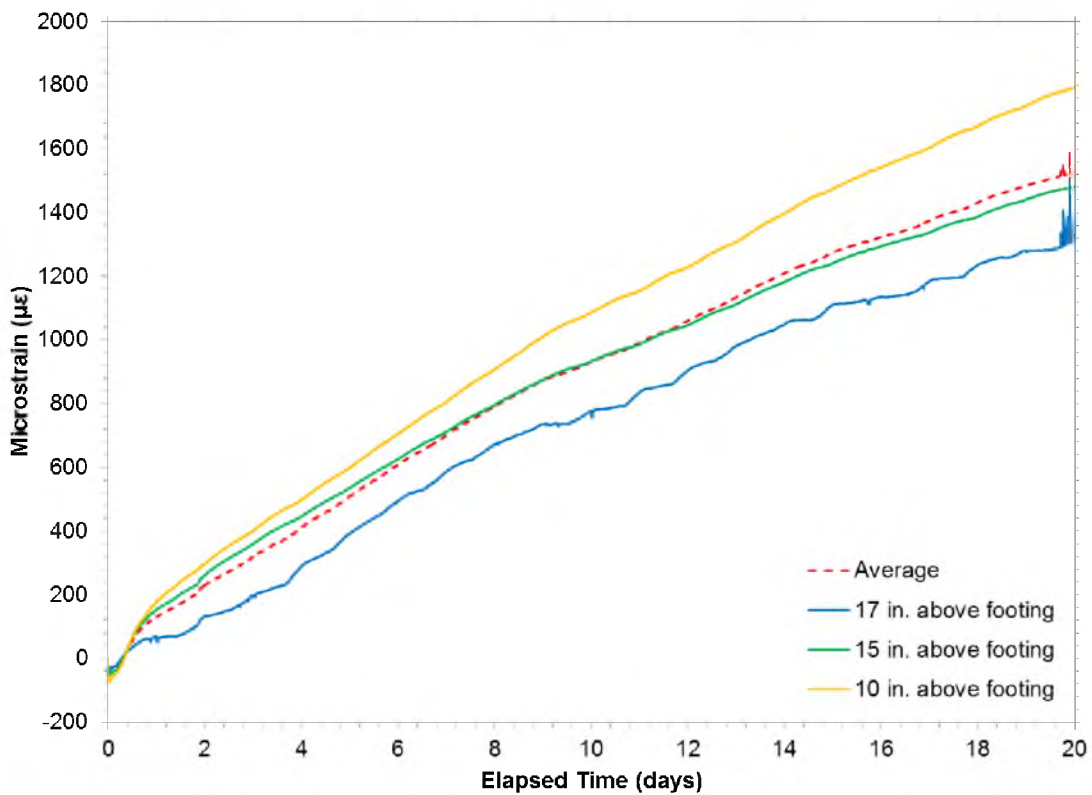
Figure 4.2 – CFRP pre-tensioning by height for NMB-3 Repair prior to testing

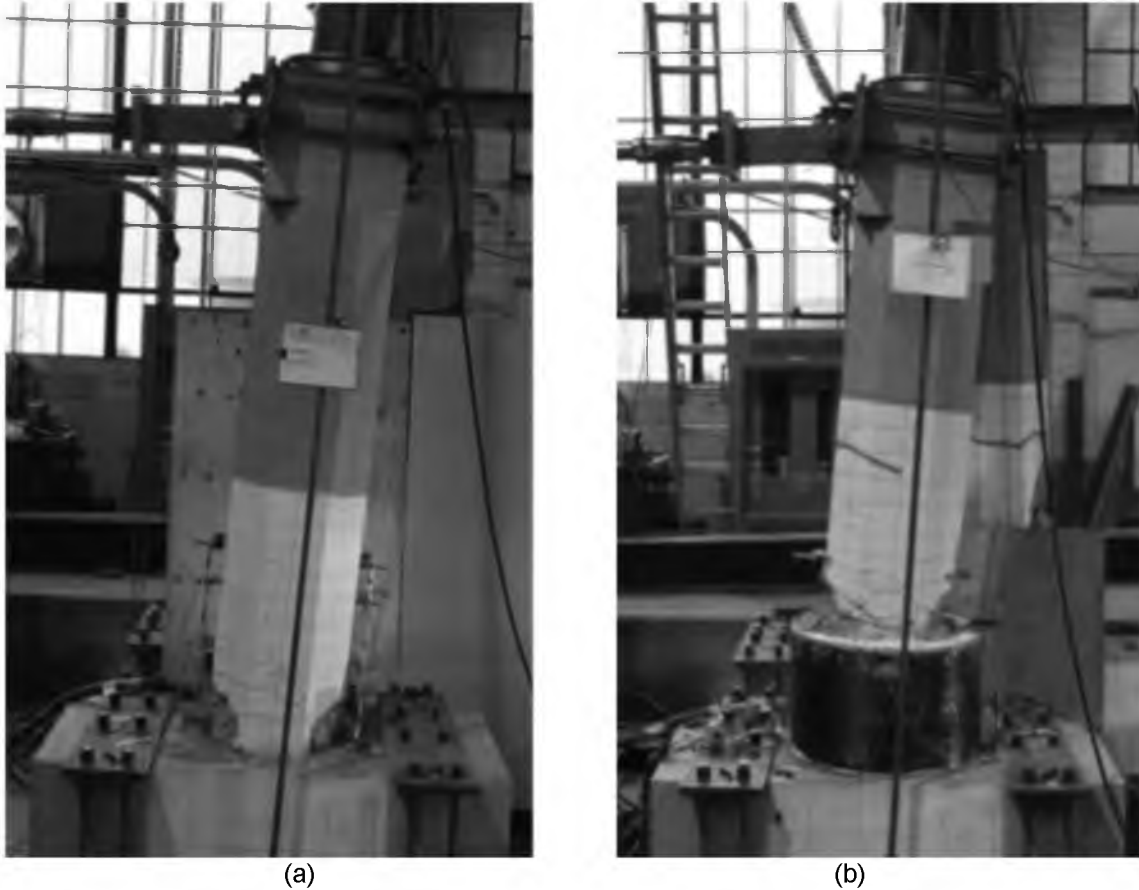
Figure 4.3 – Specimens displaced to the east at the maximum displacement step: (a) NMB-2, (b) NMB-2 Repair

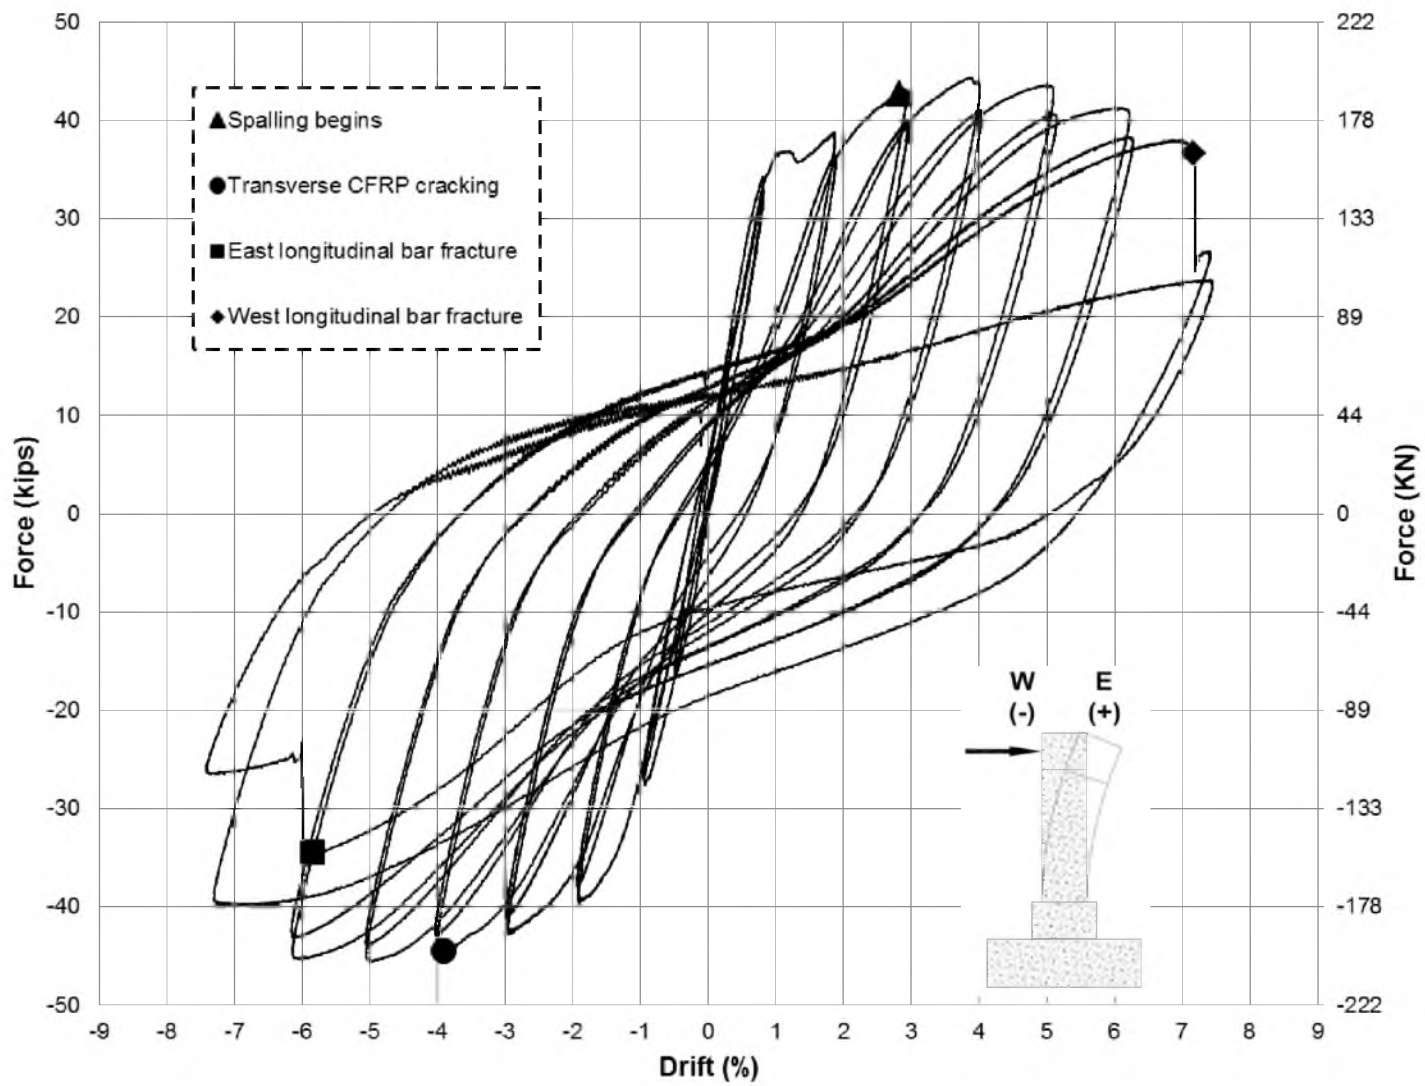
NMB-2 Repair reached an ultimate lateral load during the 4-in. to 5-in. displacement step and experienced longitudinal rebar fracture of both the west and east extreme bars during the 7-in.

Figure 4.4 – NMB-2 Repair hysteresis curve

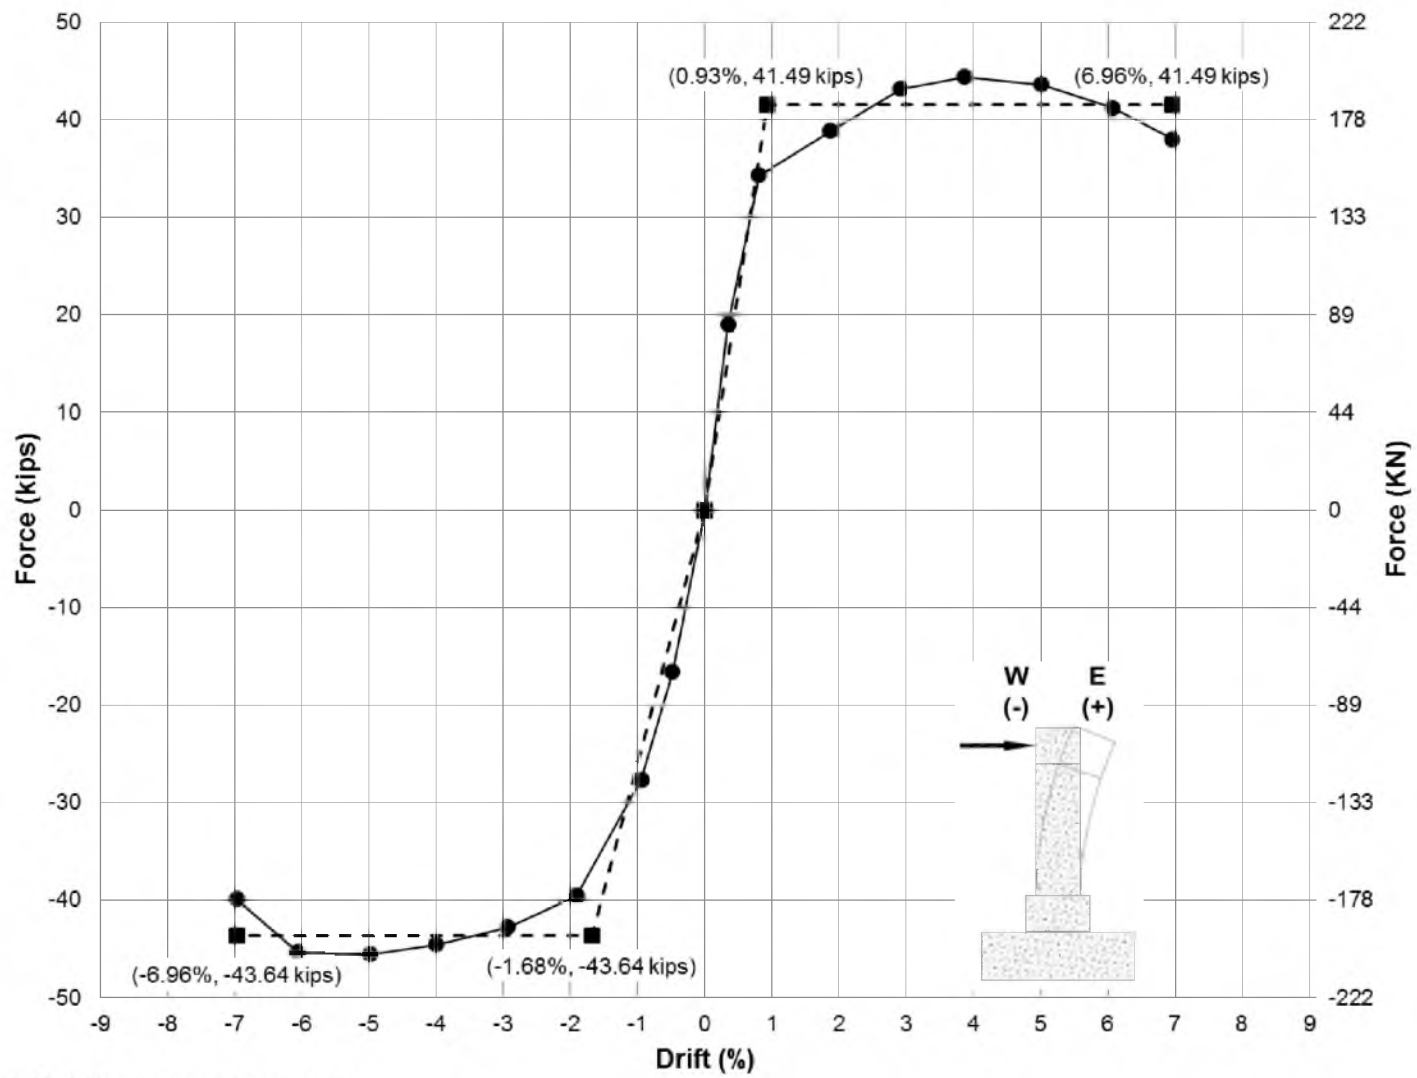
Figure 4.5 – NMB-2 Repair backbone curve

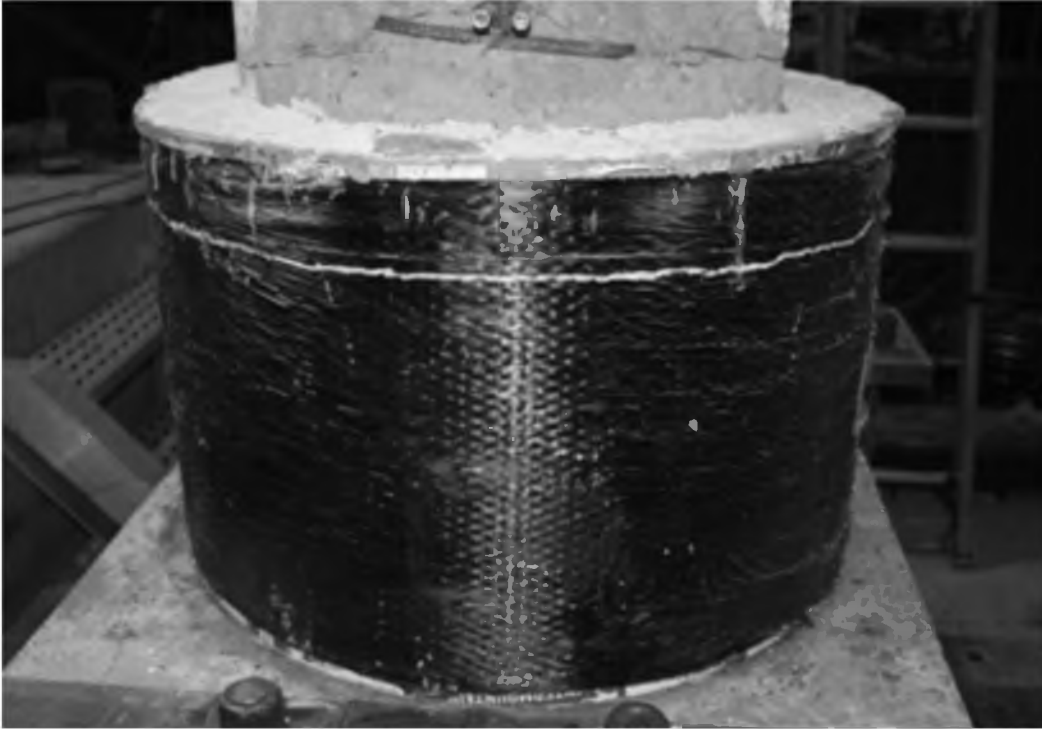
Figure 4.6 – Transverse CFRP crack located just above white line

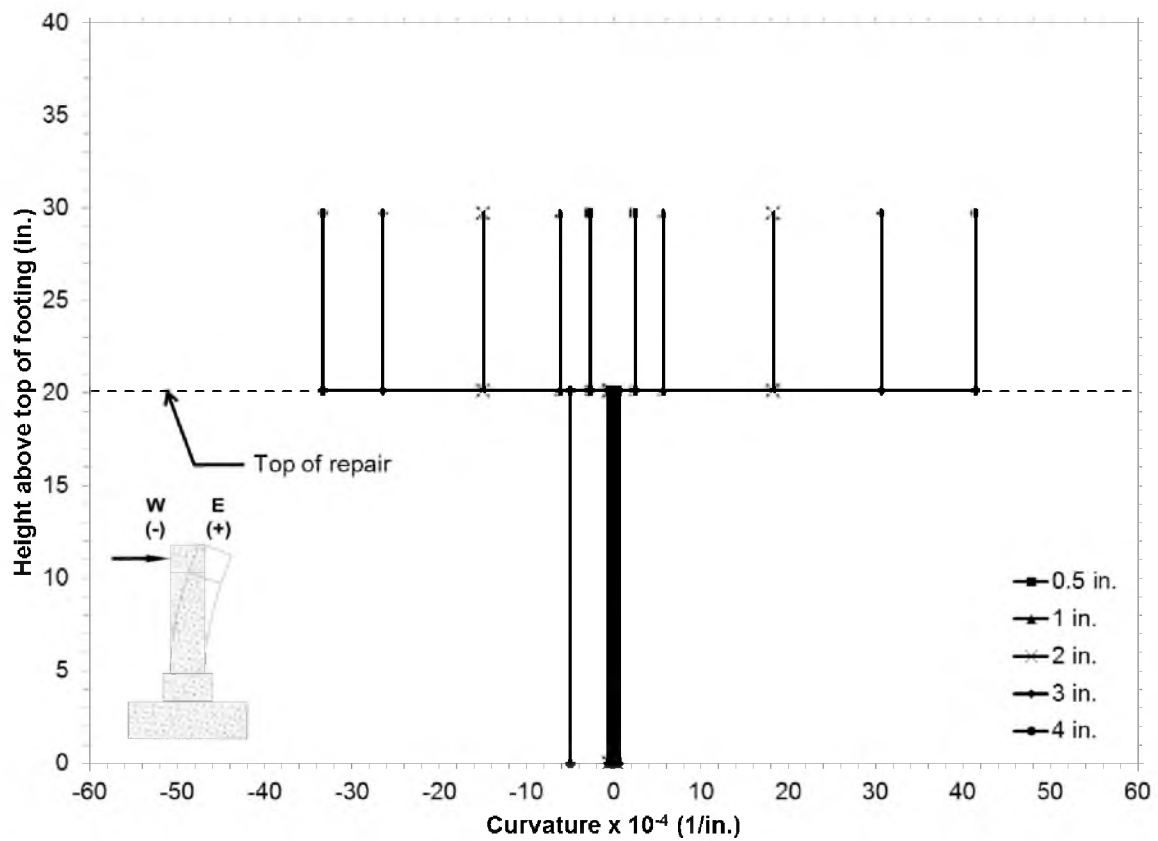
The onset of transverse CFRP cracking can be seen from the curvature profile, shown in Figure 4.7, which shows the maximum and minimum curvatures during the 0.5 in. to 4-in. displacement steps. There are two curvature values plotted for each displacement step in the

Figure 4.7 – NMB-2 Repair curvature profile up to 4-in. displacement step

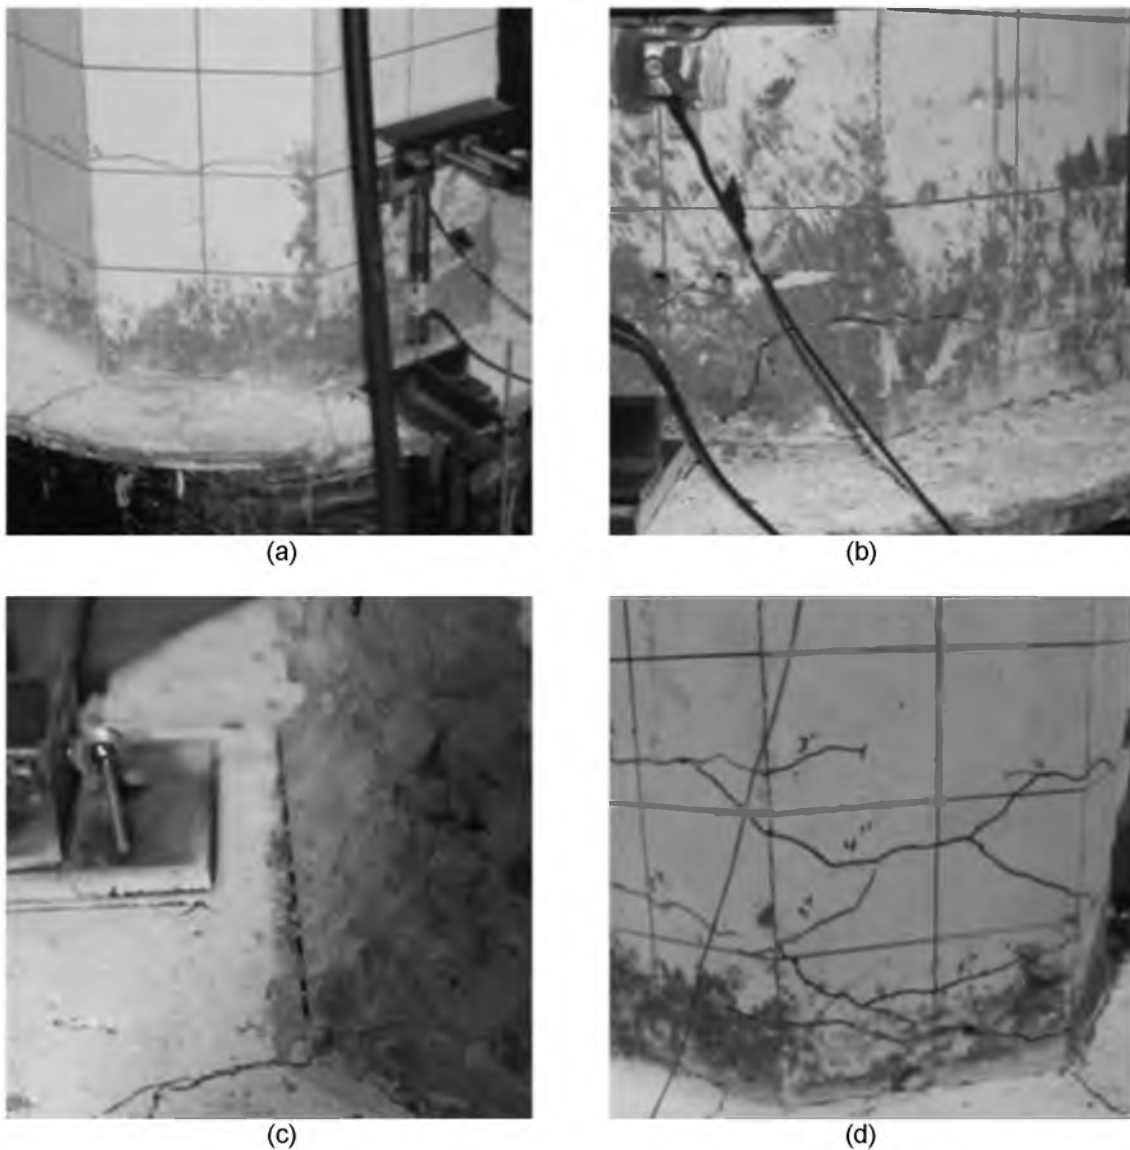
During the first cycle of the 4-in. displacement step the transverse CFRP crack, discussed previously, originated on the east side of the repair when the column was displaced to the west. During this displacement step, shear x-cracking began on both the north and south faces, as shown in Figure 4.8(d). The x-cracks were measured to have a maximum width of 0.013 in. Spalling of the cover concrete above the repair continued during this displacement step.

Figure 4.8 – NMB-2 Repair test pictures through the 6-in. displacement step: (a) Radial cracks after 1-in. displacement step, (b) First cracking occurring during 2-in. displacement step, (c) Gapping between repair-column interface during the 6-in. displacement step, (d) Shear x-cracking after the 4-in. displacement step
