POSTEARTHQUAKE REPAIR OF PRECAST CONCRETE
COLUMN-TO-FOOTING PLASTIC HINGES

Dylan Neil Brown

A thesis submitted to the faculty of
The University of Utah
in partial fulfillment of the requirements for the degree of

August 2014

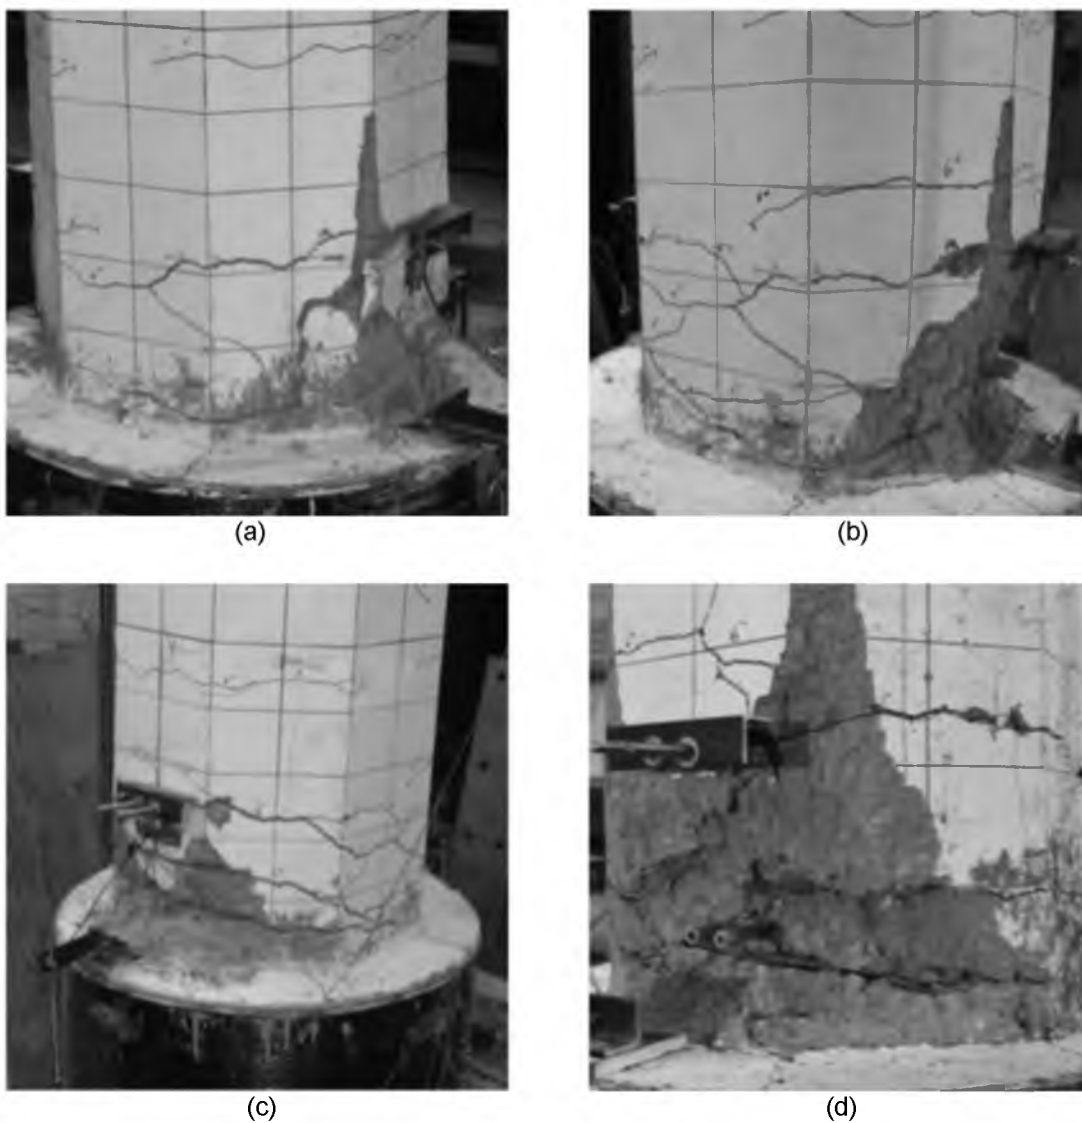
No new cracking was observed during the 6-in. displacement step. The cracks located approximately 10 in. above the top of the repair increased in width from hairline to 0.1 in. and

Figure 4.9 – NMB-2 Repair test pictures through final damage state: (a) Major spalling during 5-in. displacement step, (b) Damage level after 6-in. displacement step, (c) Damage state during 7-in. displacement step, (d) Final damage state

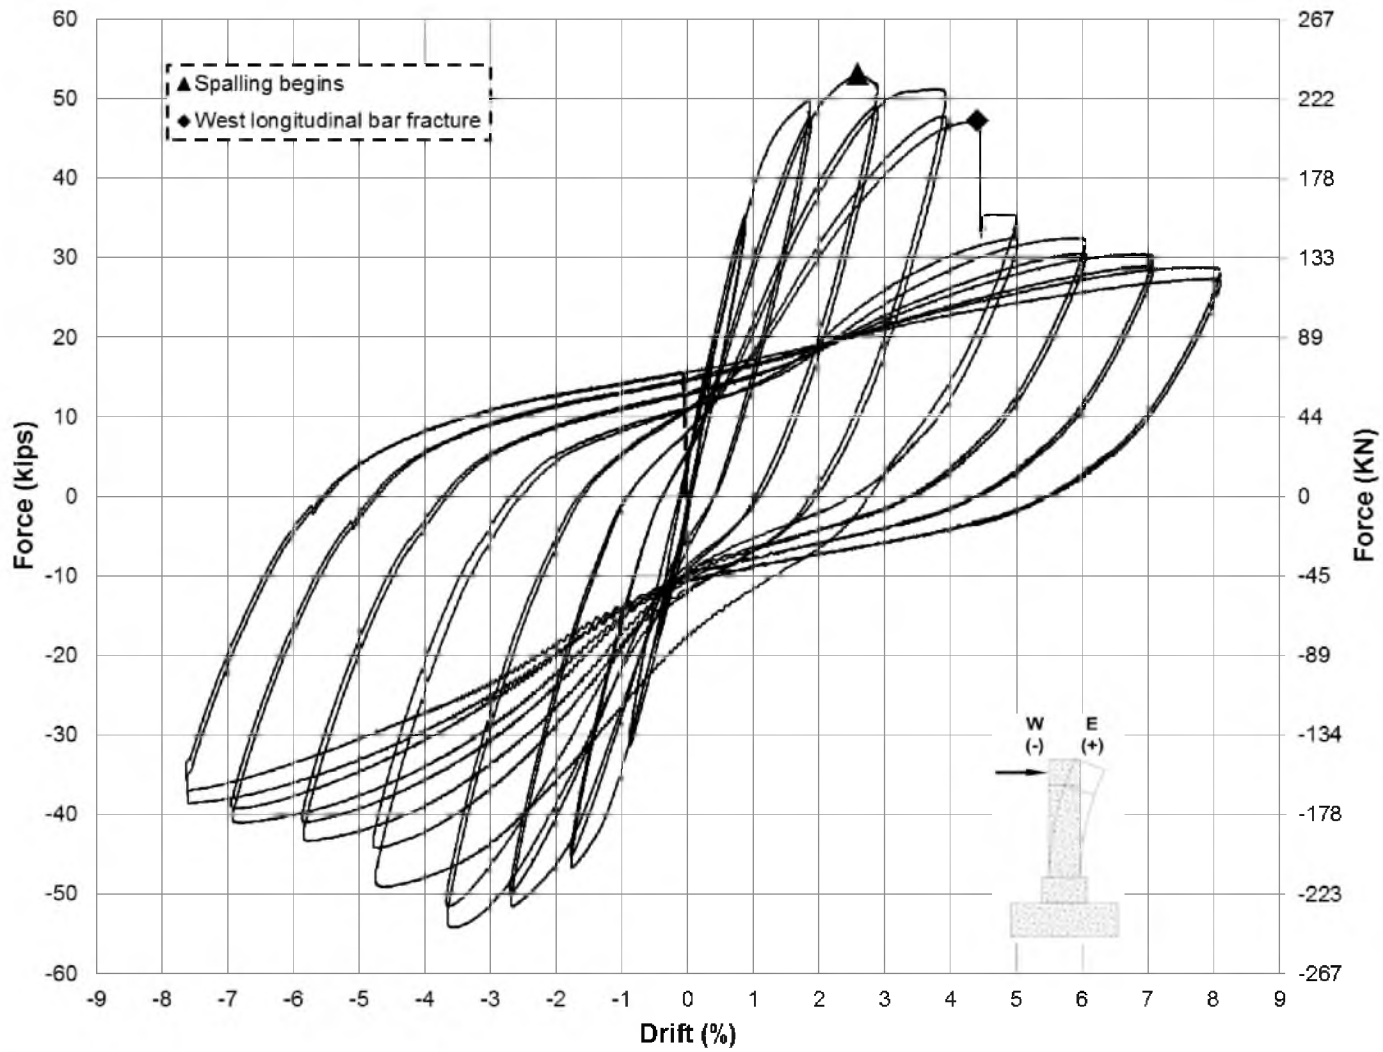
The objectives in repairing NMB-3 Repair were to restore the diminished load and displacement capacity of NMB-3 through plastic hinge relocation. The hysteretic performance of NMB-3 Repair is shown in Figure 4.10, and response envelope is shown in Figure 4.11. Plastic hinge relocation was achieved and is shown in Figure 4.12. The load capacity of NMB-3 Repair was improved by 30% when compared to NMB-3. It can be seen from the envelope that the ultimate drift achieved was 4.60% in the east direction and 5.89% in the west direction. A 20% drop in lateral load carrying capacity was reached in both directions between the 5-in. and 6-in. displacement steps; testing continued through the 8-in. displacement step. The damage state of NMB-3 Repair at displacement steps prior to the 6-in. displacement step can be seen in Figure 4.13. The displacement ductility in the east and west directions was 3.86 and 3.88, respectively. This is over a 40% decrease in displacement ductility from NMB-3. The failure mode of the specimen was longitudinal bar fracture of west extreme longitudinal rebar 10.25 in. above the top of the repair. The fracture occurred during the first cycle of the 5-in. displacement step in the east direction. The damage state of NMB-3 Repair after testing is shown in Figure 4.14.

Figure 4.10 – NMB-3 Repair hysteresis curve

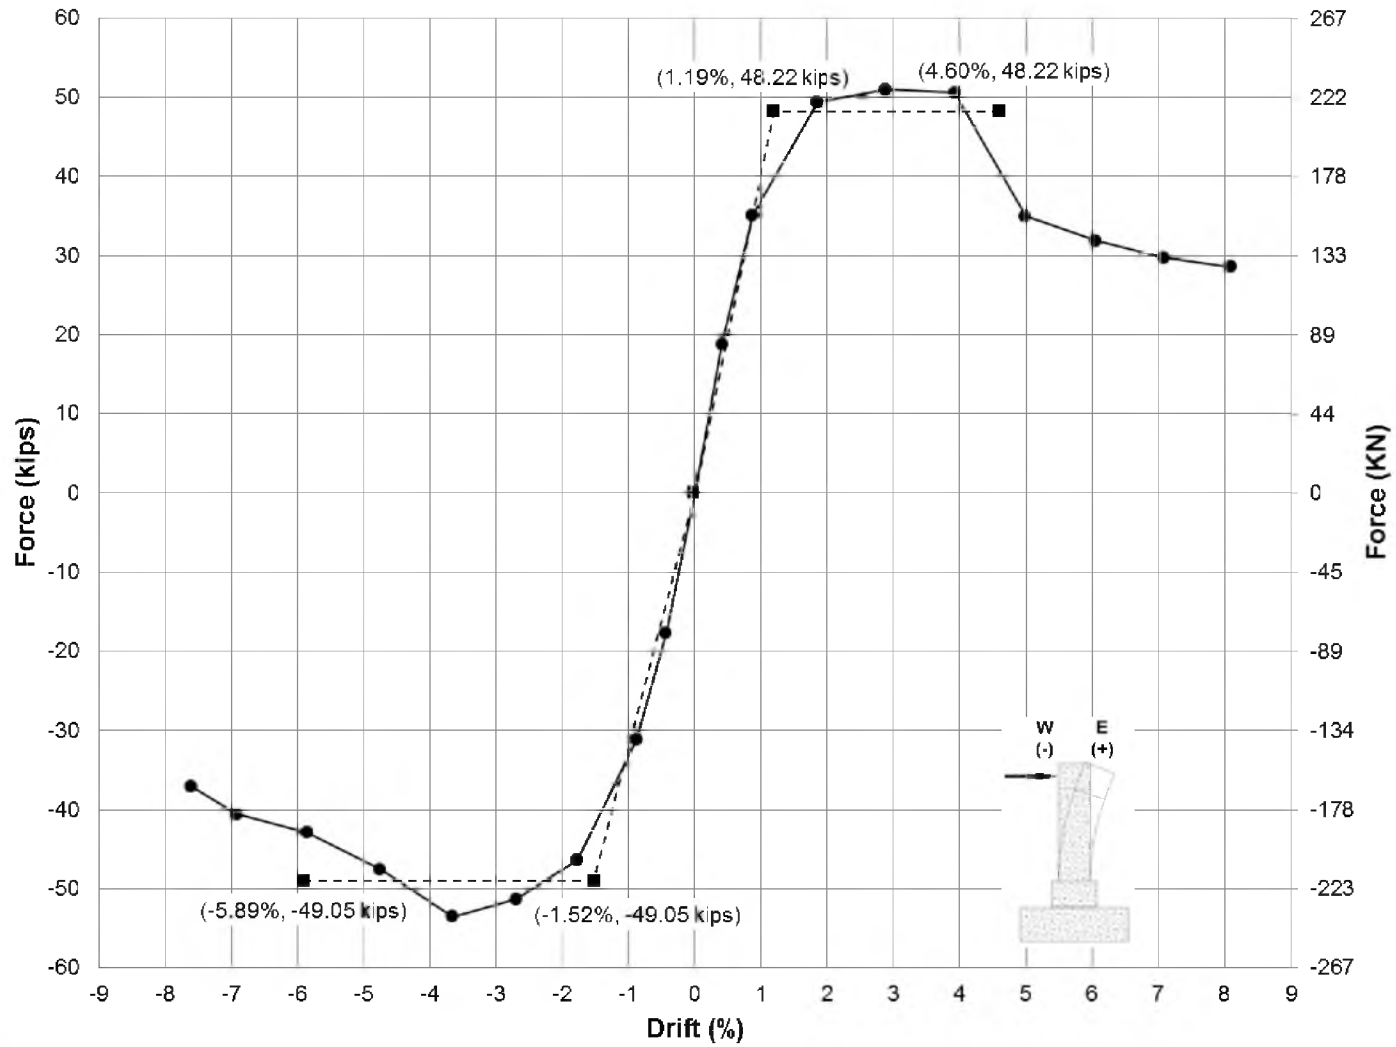
Figure 4.11 – NMB-3 Repair envelope curve

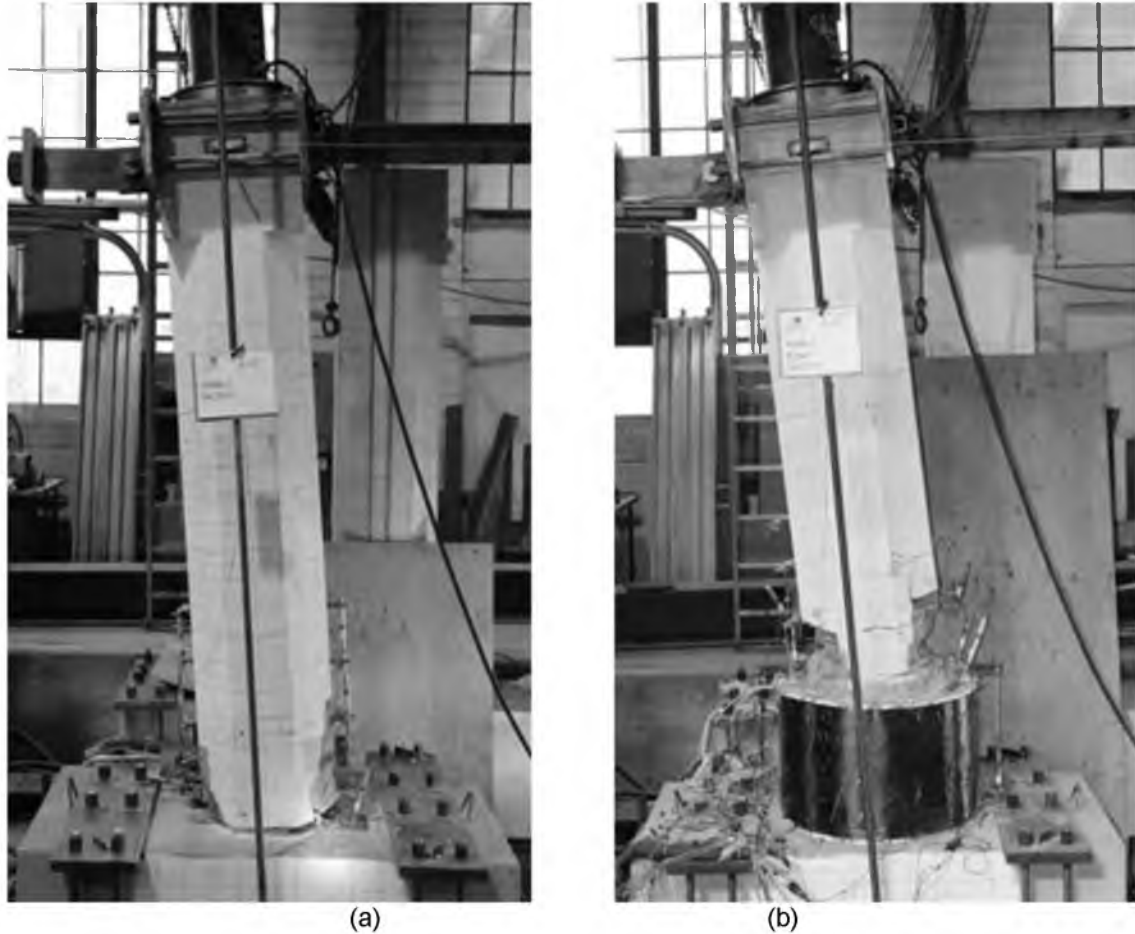
Figure 4.12 – Specimens displaced to the west at the maximum displacement step: (a) NMB-3, (b) NMB-3 Repair

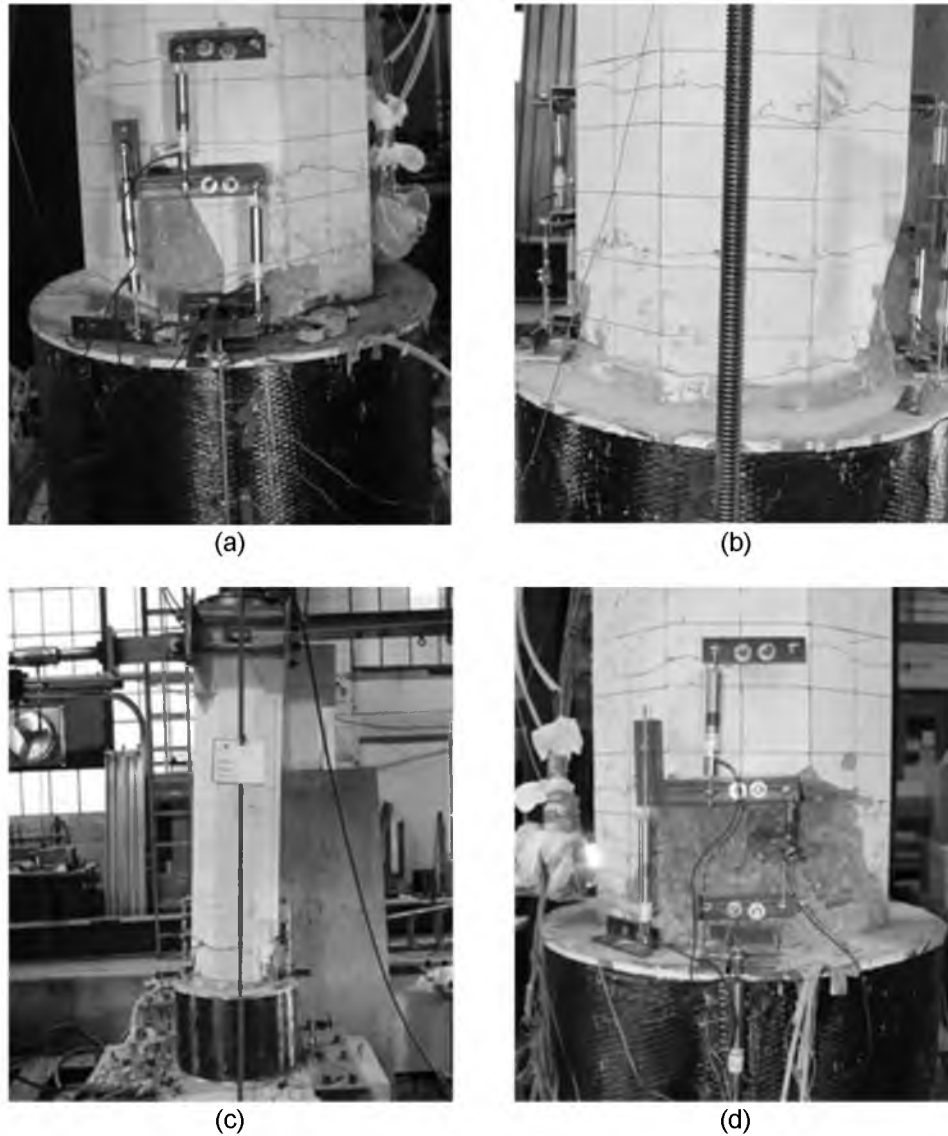
Figure 4.13 – NMB-3 Repair test pictures through 5-in. displacement: (a) Spalling on east face after 3-in. displacement step, (b) Onset of minor shear x-cracking after 4-in. displacement step, (c) The displacement in which fracture occurred, 5-in. displacement step, (d) Damage on west side after 5-in. displacement step

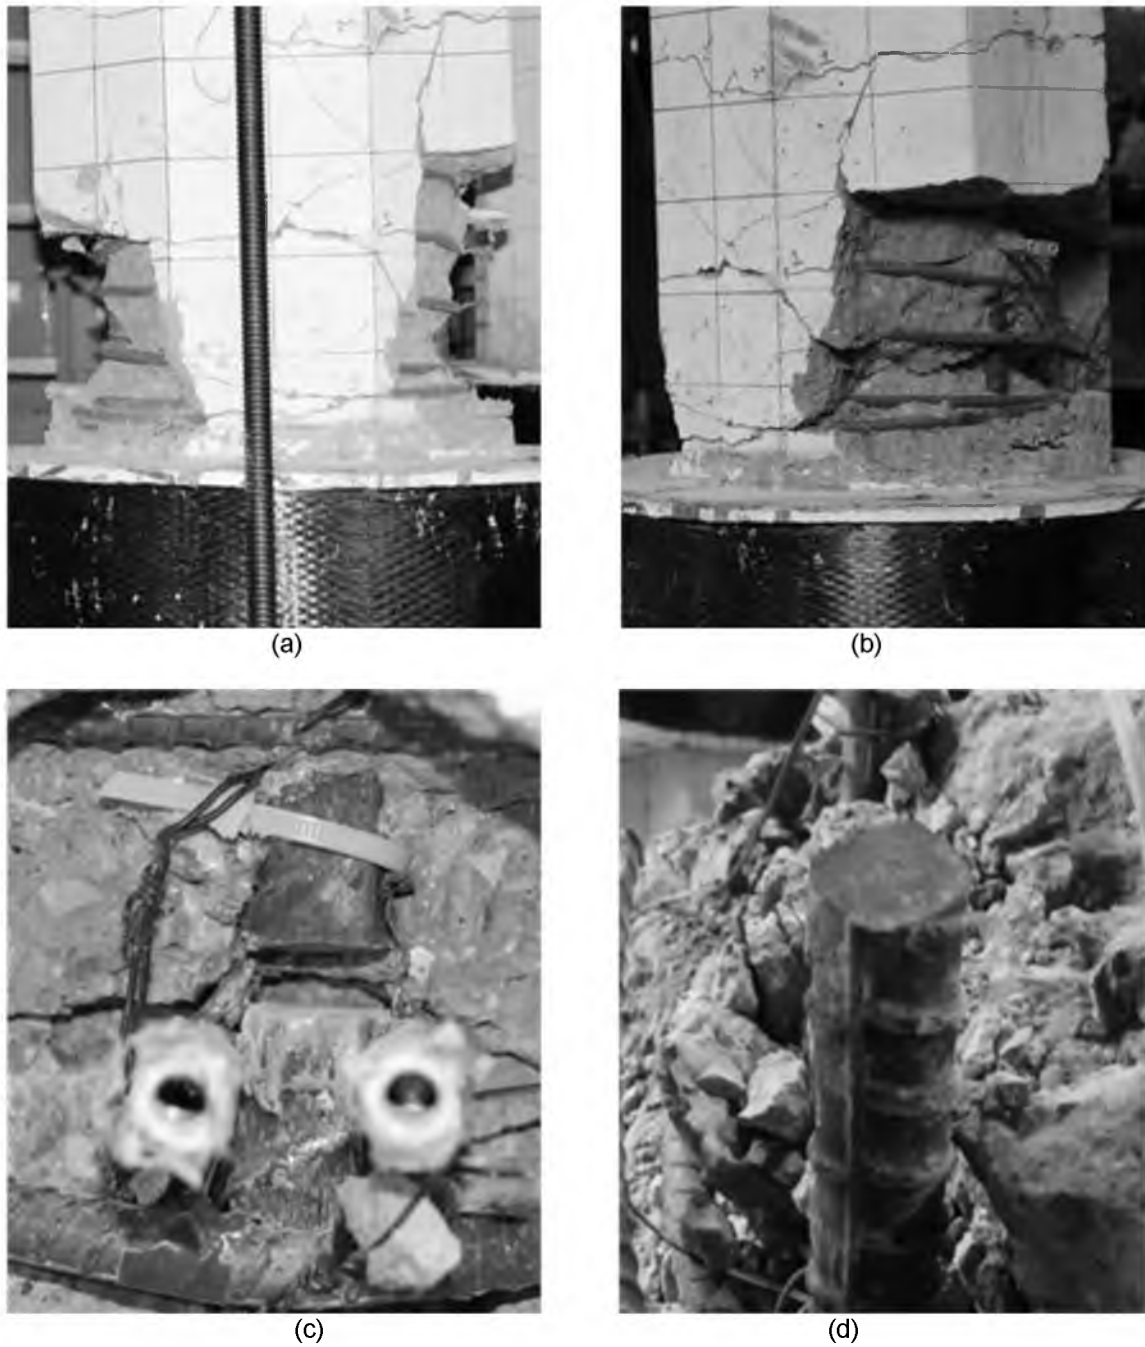
The failure surface on the top of the west longitudinal rebar is nearly perfectly smooth and flat, indicating a brittle failure, as shown in Figure 4.14(d). This type of failure surface is

Figure 4.14 – NMB-3 Repair at the completion of testing: (a) Plastic hinge region, (b) East side of plastic hinge region, (c) West longitudinal rebar fracture at completion of test, (d) West longitudinal rebar fracture after removing the concrete

The west longitudinal rebar fracture during the NMB-3 Repair test is believed to be premature. The type of fracture and the location seem to indicate that the rebar was embrittled from welding the all thread rods to the longitudinal rebar. The location of the fracture was in-between two all thread rods. Both of these rods had been tack welded onto the west longitudinal rebar to create a connection to attach LVDTs to during testing. The rebar cage prior to casting and the LVDT rods are shown in Figure 2.5 (c). Typical tack welds were used to secure the LVDT rods, shown in Figure 4.15. The fractured bar is shown in Figure 4.14. The fracture location was 10.5 in. above the top of the repair, corresponding to 30 in. above the top of the footing. This fracture location is higher than a typical longitudinal rebar flexural fracture. In the NMB-2, NMB-2 Repair, and NMB-3 tests, the rebar fractured within 0 in. to 4.5 in. from the

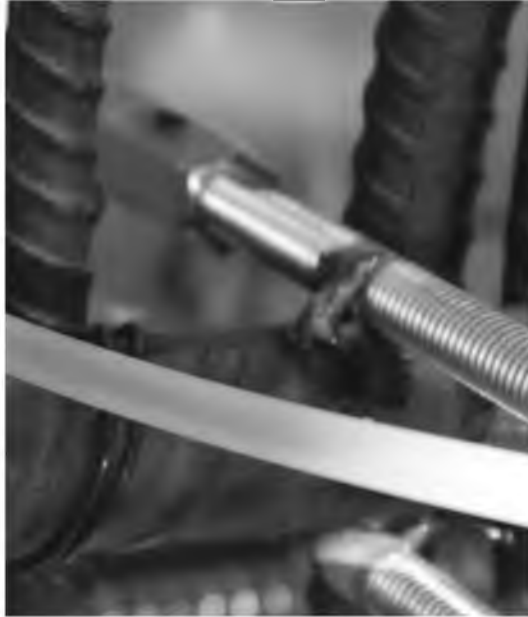
Figure 4.15 – Typical tack weld used to connect LVDT rods to the column longitudinal rebar

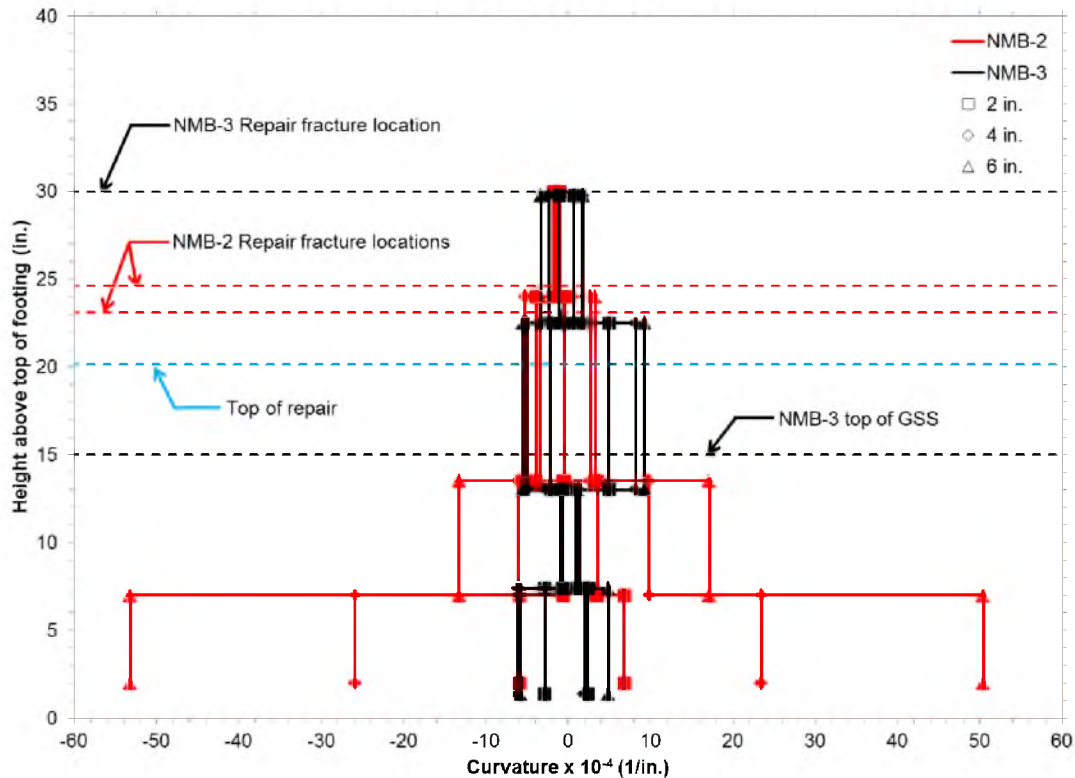
The location of the GSS in NMB-2 and NMB-3 were different, causing the loading history of the longitudinal rebar to differ. NMB-2 had the GSS located in the footing which caused the deflection of the column to behave in a monolithic fashion. NMB-3 had the GSS located in the column, which caused the column to deflect in a rocking manner, concentrating the plasticity within the footing. Curvature profiles illustrate these differences in deflection characteristics between the as-built NMB-2 and NMB-3 specimens, which are shown in Figure 4.16. The curvature profiles for the 2-in., 4-in. and 6-in. displacement steps are shown in Figure 4.16. NMB-3 experienced more curvature at heights above the future repair than NMB-2. This indicates that

Figure 4.16 – Curvature profiles of NMB-2 and NMB-3

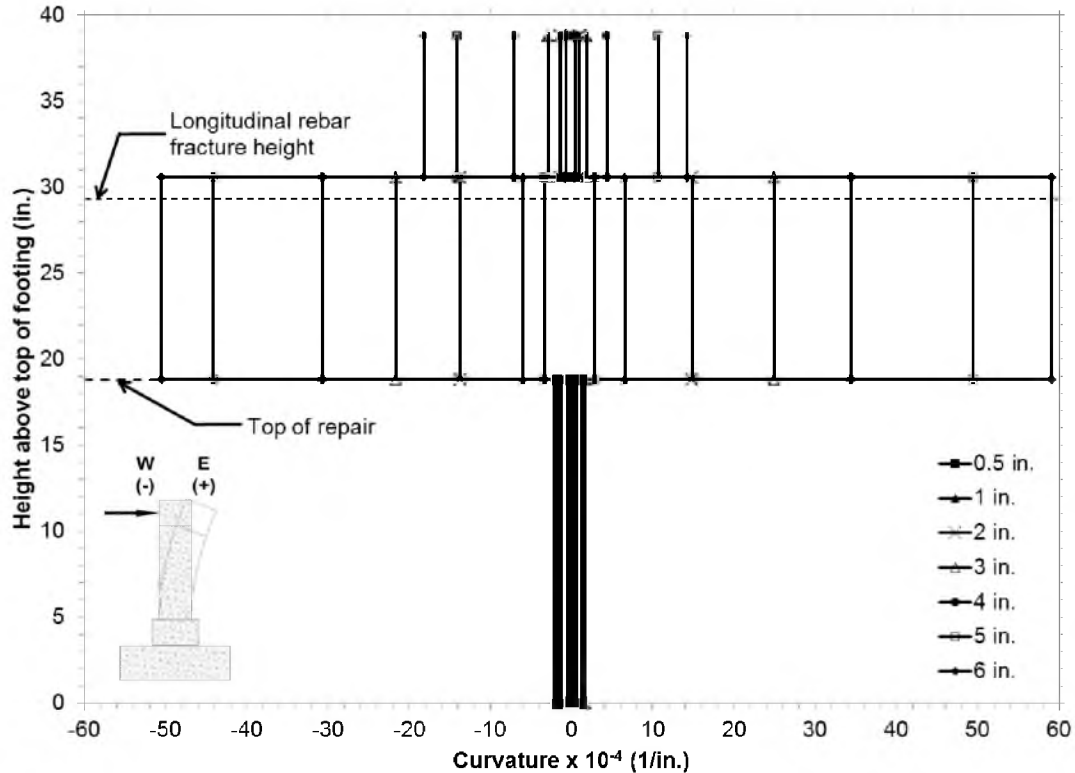
Other notable features of the damage states of the NMB-3 Repair experienced during testing will be explained chronologically. During the 0.5-in. displacement step no damage was observed. The 1-in. displacement step created two new levels of hairline cracks at 8 in. and 18 in. above the top of the repair and opened up the crack obtained during NMB-3 test at 2 in. to 4 in.

Figure 4.17 – NMB-3 Repair curvature profile

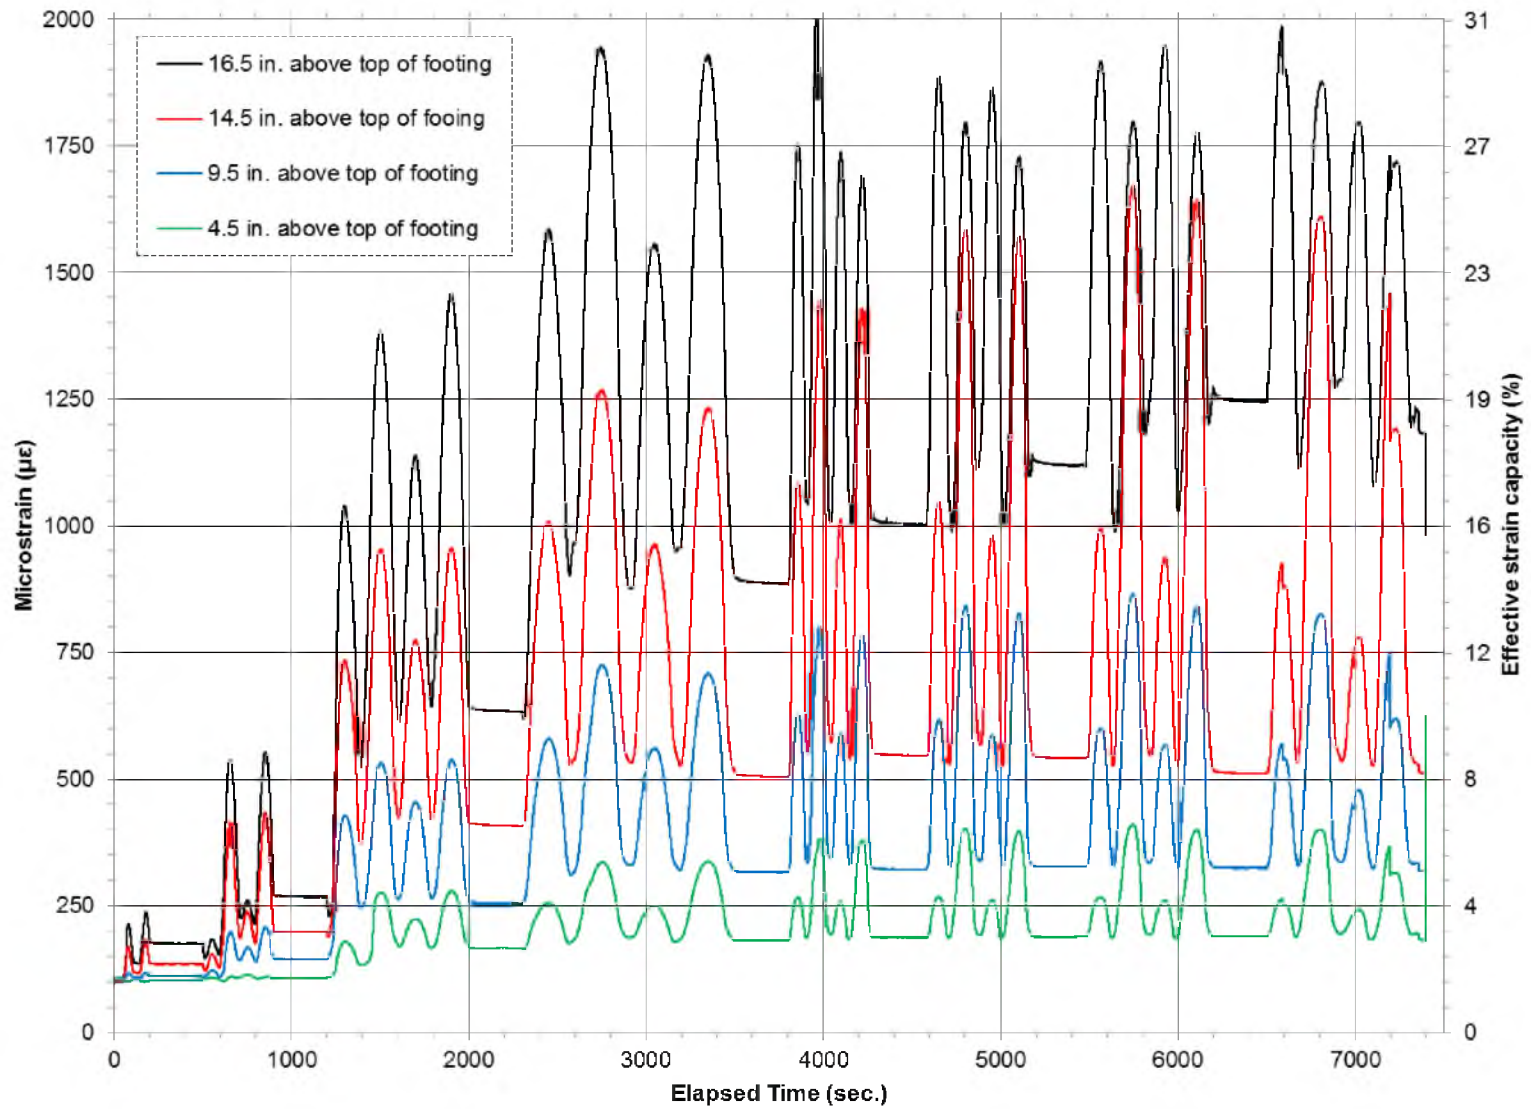
Uneven straining of the jacket, when displaced east and west, is shown in Figure 4.18. The second displacement in each cycle, corresponding to a displacement in the east direction, experiences more strain than in the first displacement. This uneven directional straining is

Figure 4.18 – NMB-2 Repair wrap strain gauge data averaged by height

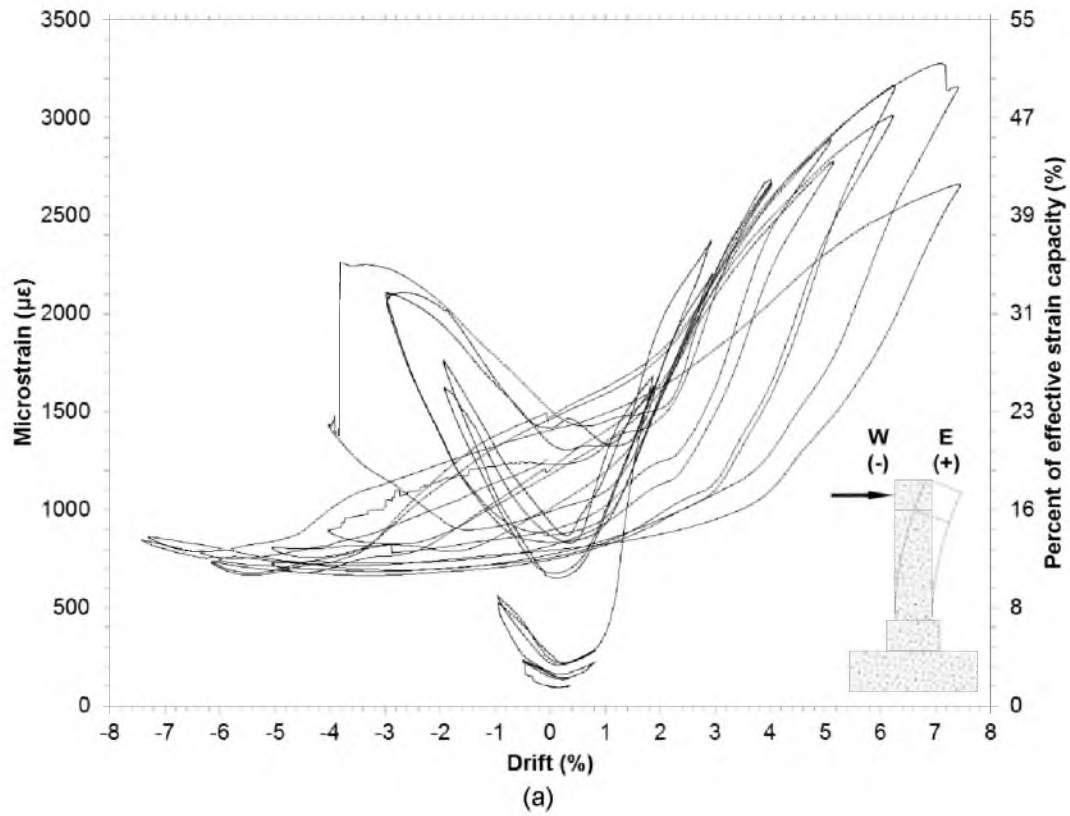
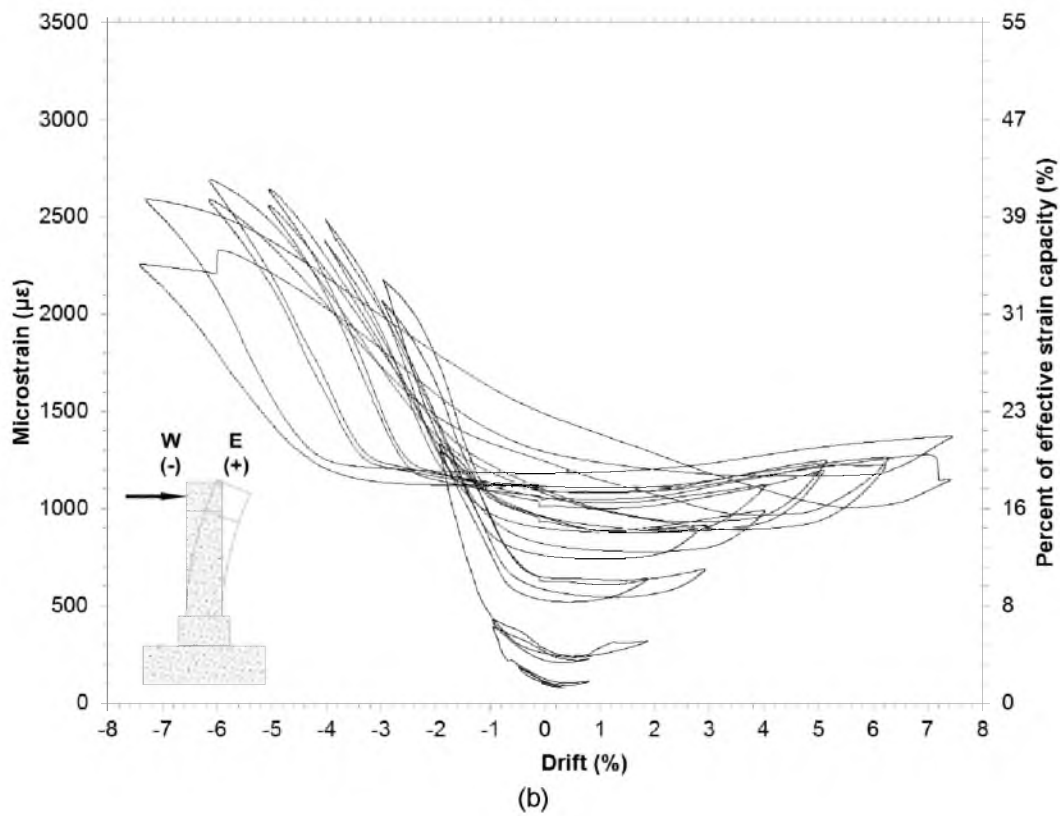
Figure 4.19 – NMB-2 Repair wrap strain gauge data from top band, 3 in. below the top of the repair: (a) East, (b) West

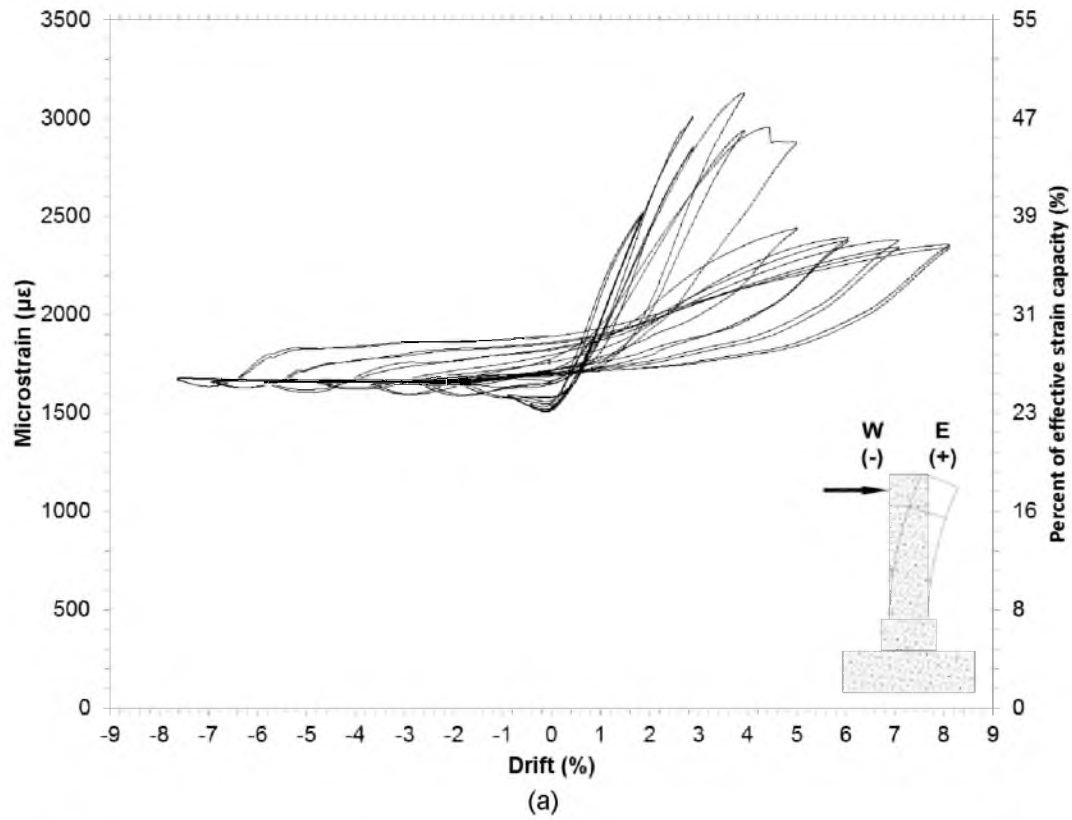
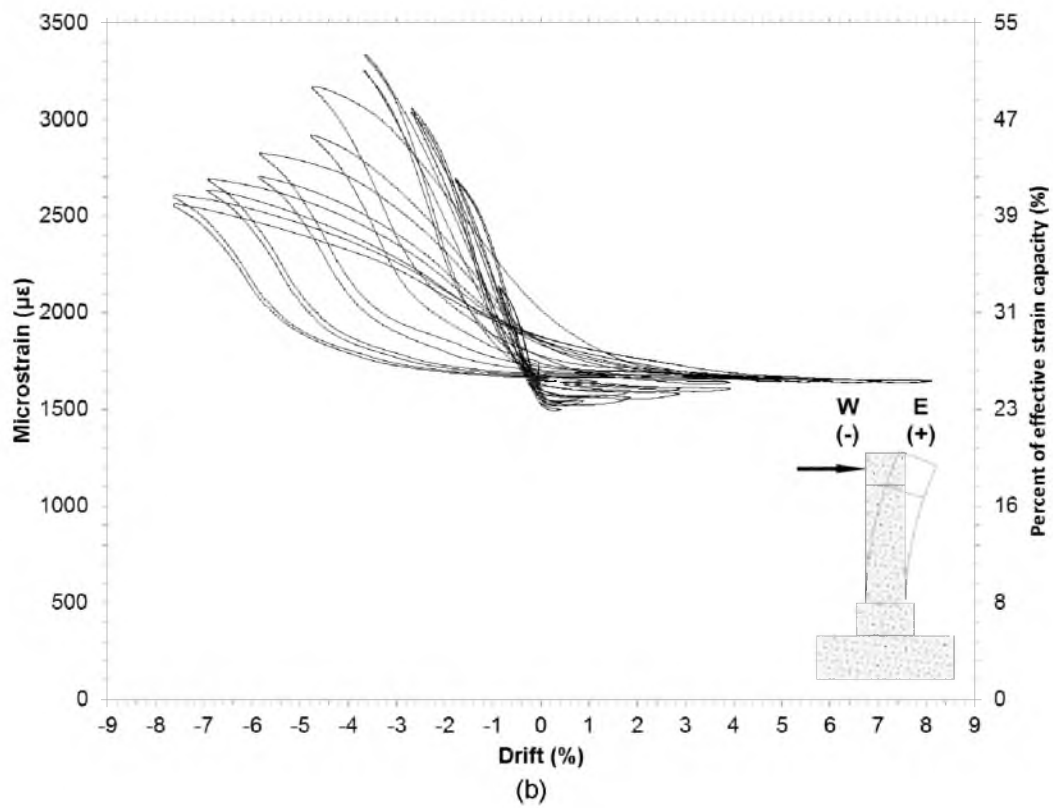
Figure 4.20 – NMB-3 Repair wrap strain gauge data from top band, 3 in. below the top of the repair: (a) East, (b) West

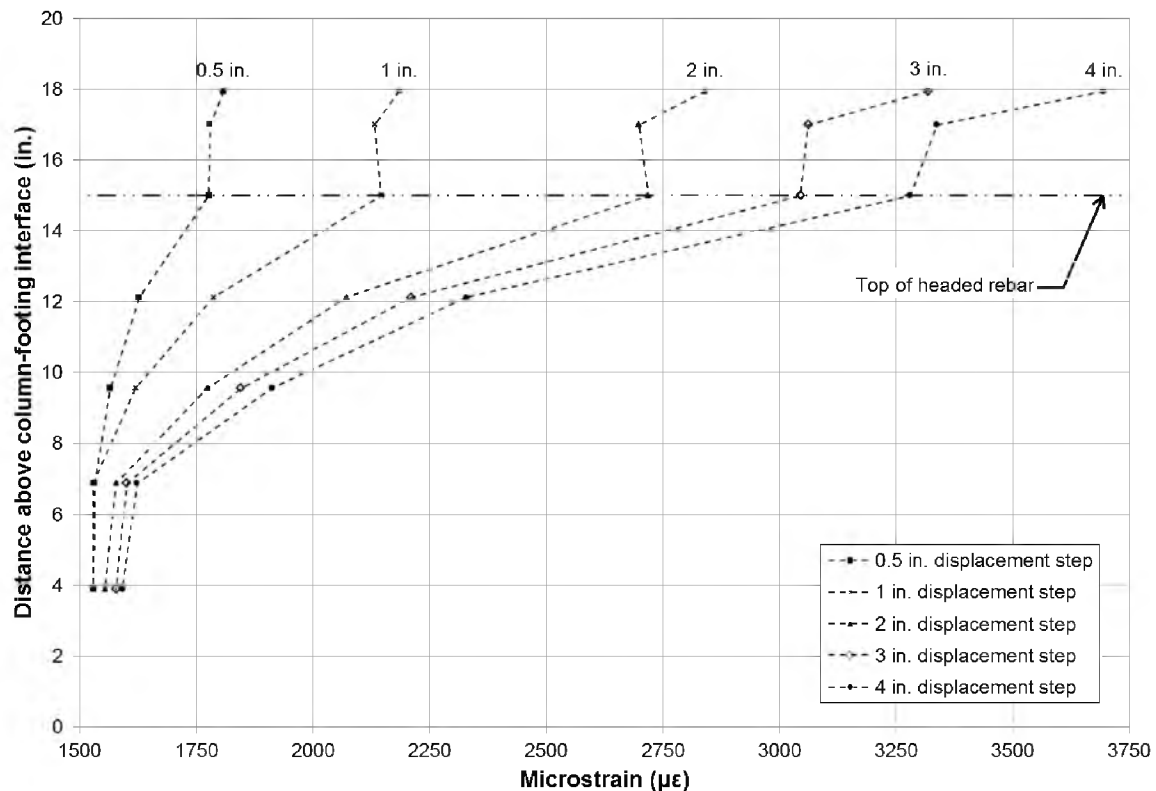
Figure 4.21 – NMB-2 Repair west face wrap strain profile up to 4-in. displacement step

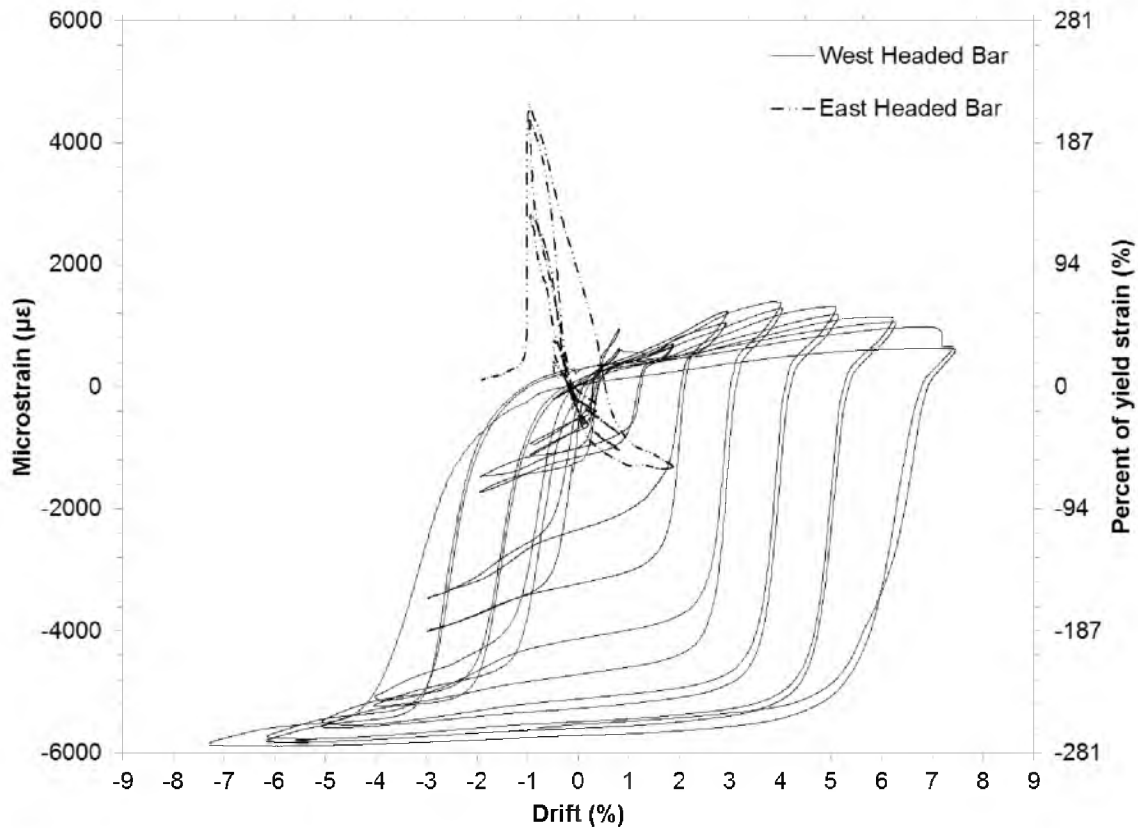
Figure 4.22 – NMB-2 Repair headed bar strain gauge data from 7.5 in. above the footing level

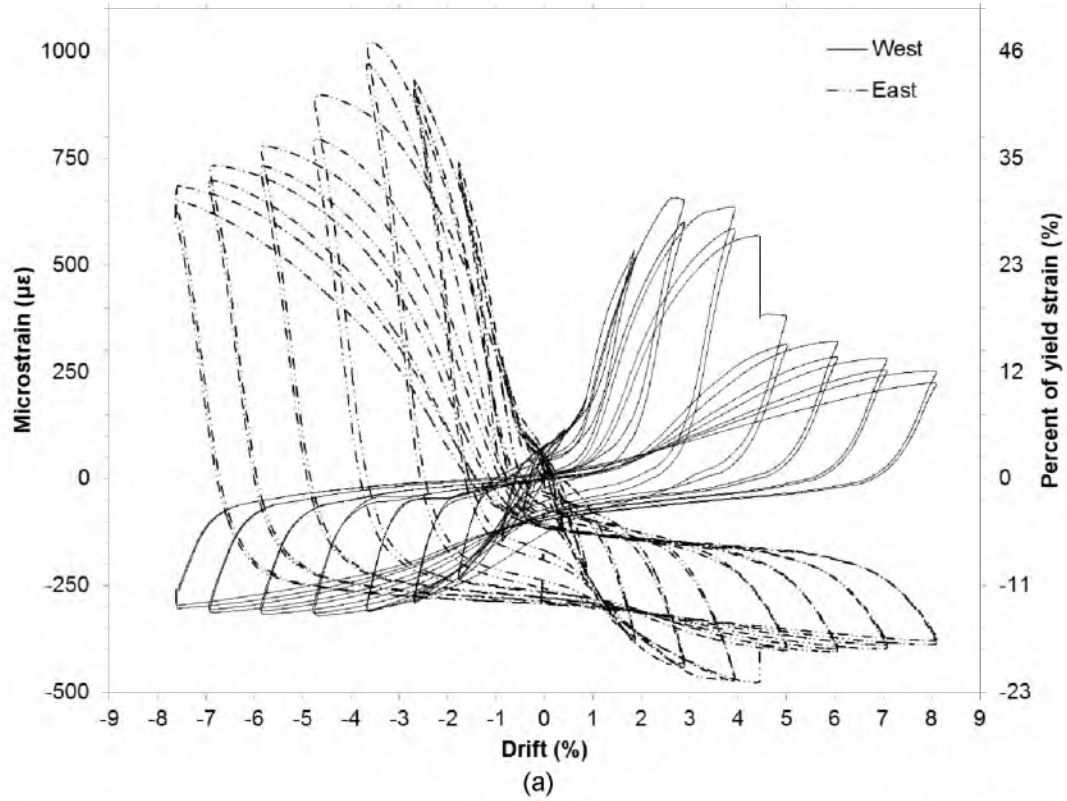
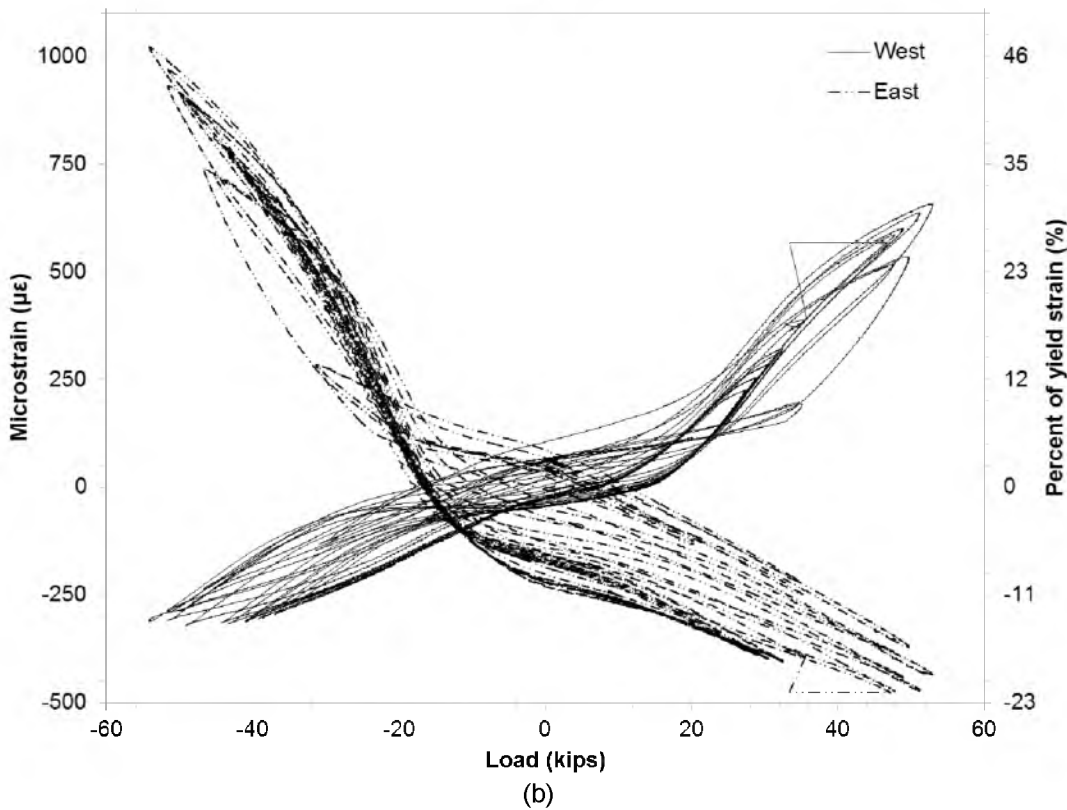
Figure 4.23 – NMB-3 Repair headed bar strain gauge data from west gauge 7.125 in. above the footing level and east gauge 6.5 in. above the footing level plotted versus: (a) Drift, (b) Load

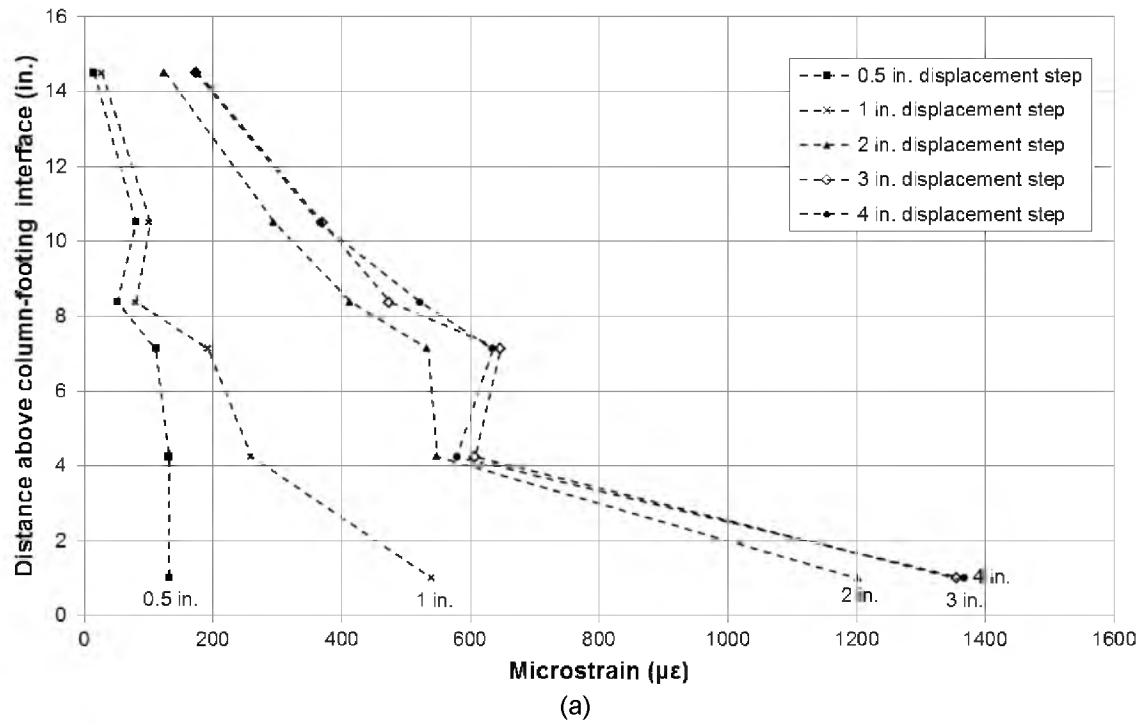
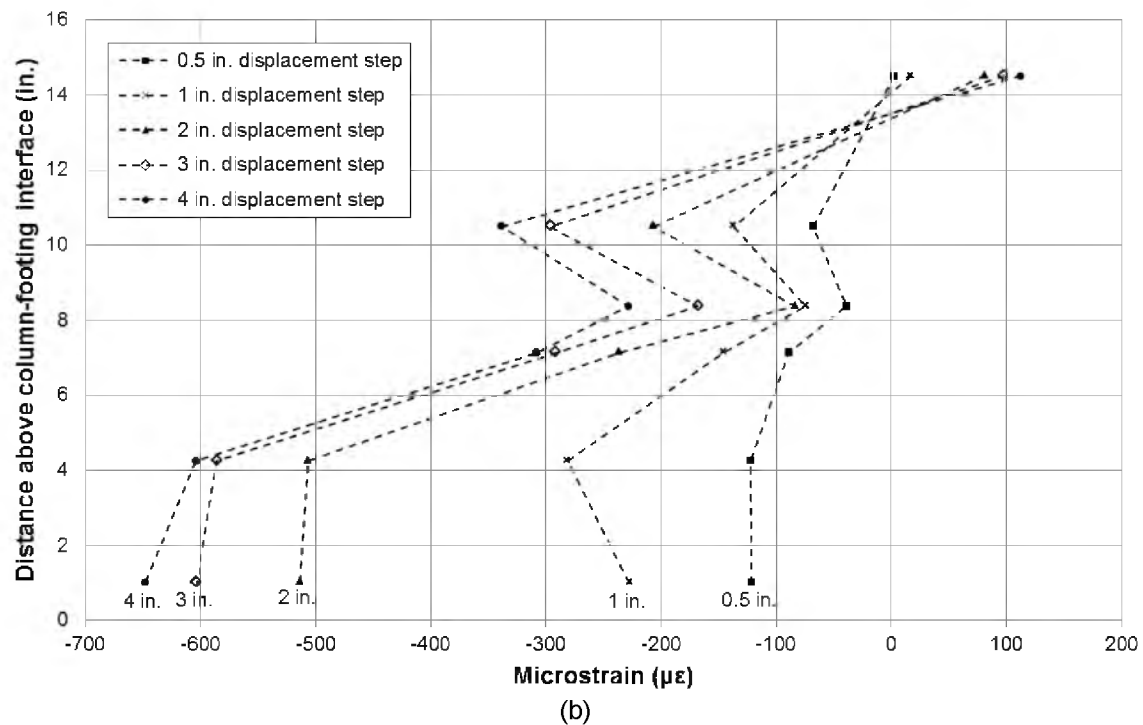
Figure 4.24 – NMB-3 Repair west headed rebar strain profile up to 4-in. displacement step: (a) Tension, (b) Compression
