POSTEARTHQUAKE REPAIR OF PRECAST CONCRETE
COLUMN-TO-FOOTING PLASTIC HINGES

Dylan Neil Brown

A thesis submitted to the faculty of
The University of Utah
in partial fulfillment of the requirements for the degree of

August 2014

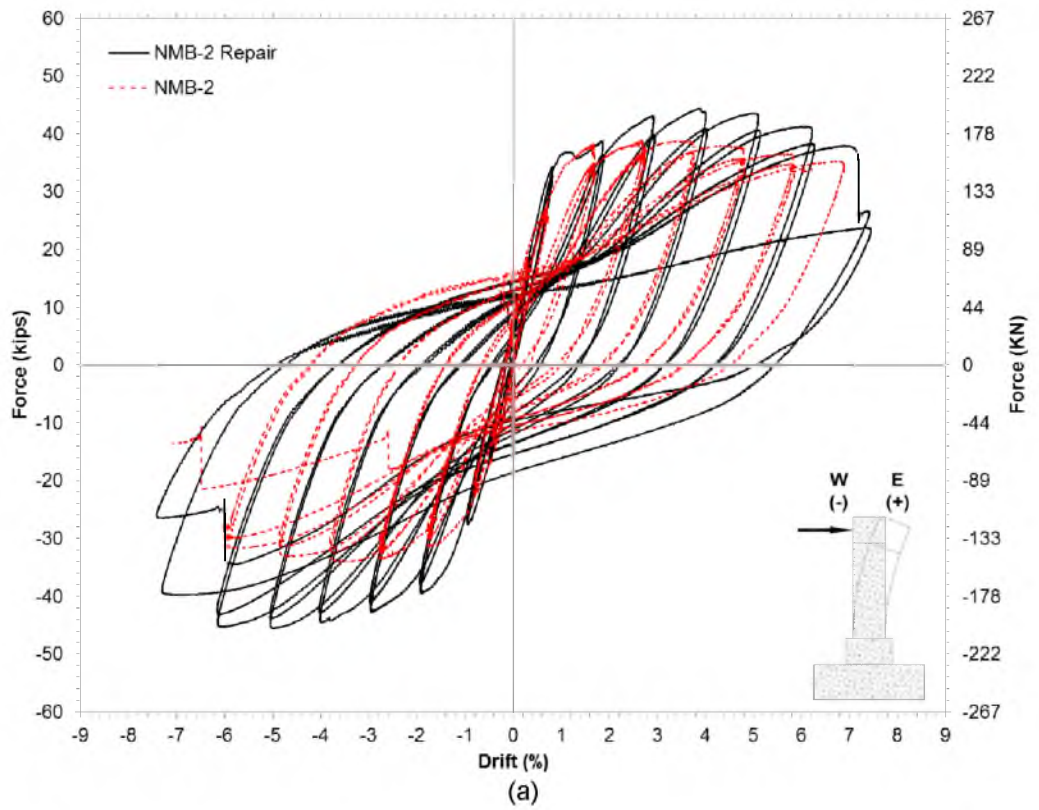
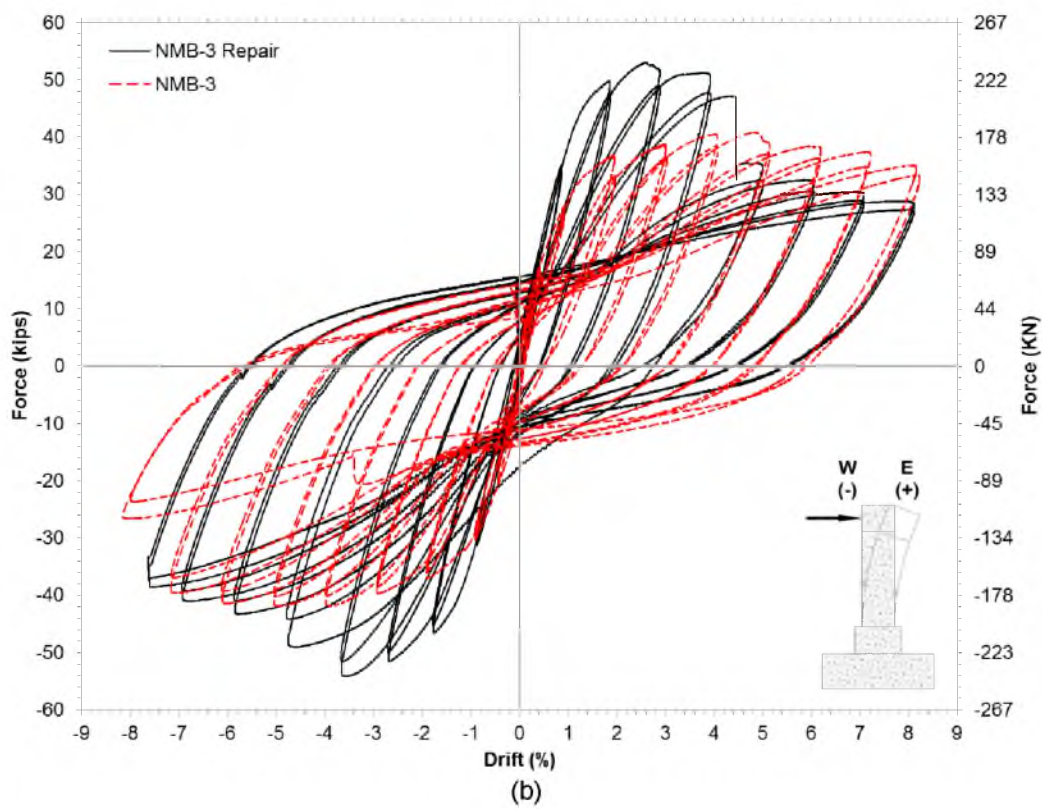
Figure 4.25 – Overlapping as-built and repair hysteresis: (a) NMB-2 and NMB-2 Repair, (b) NMB-3 and NMB-3 Repair

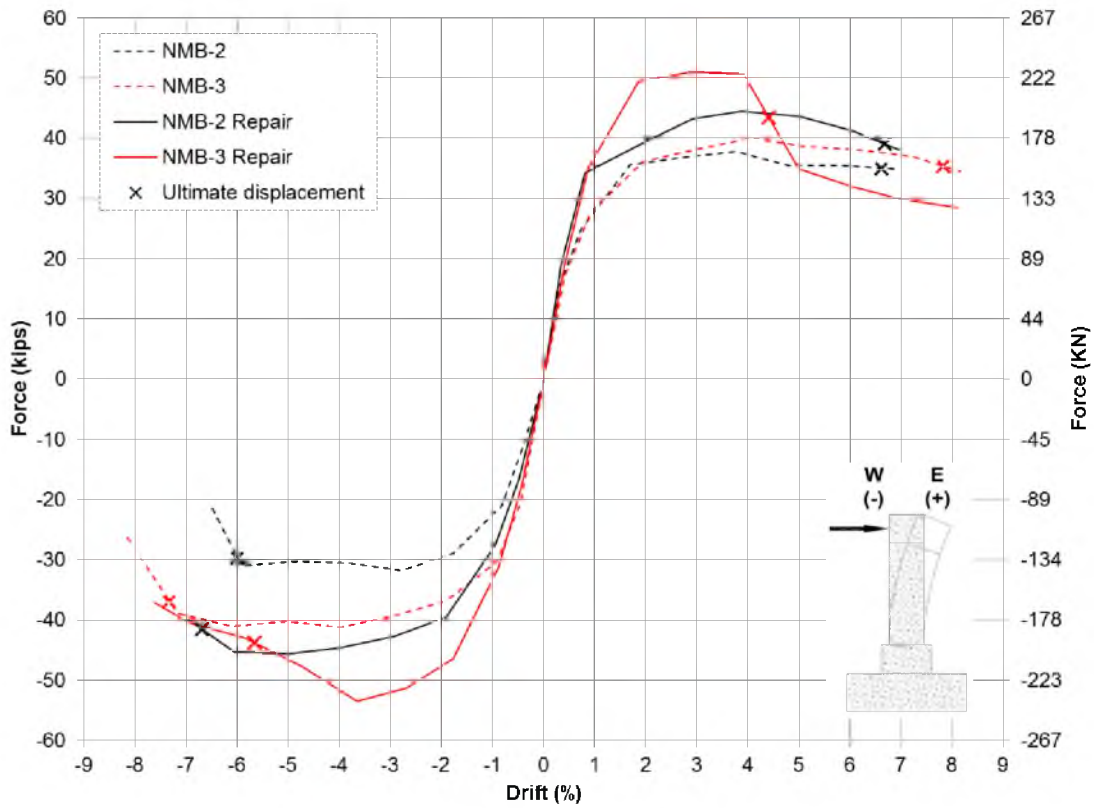
Figure 4.26 – As-built and repair testing response envelopes

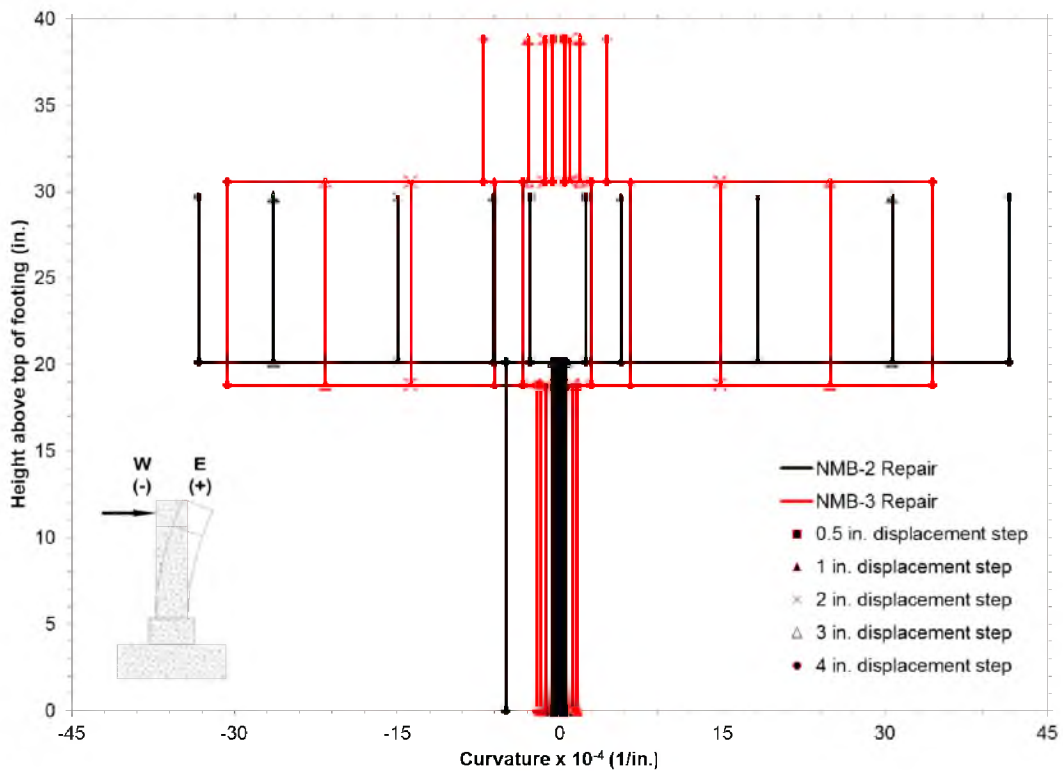
Figure 4.27 – Curvature profiles for NMB-2 Repair and NMB-3 Repair

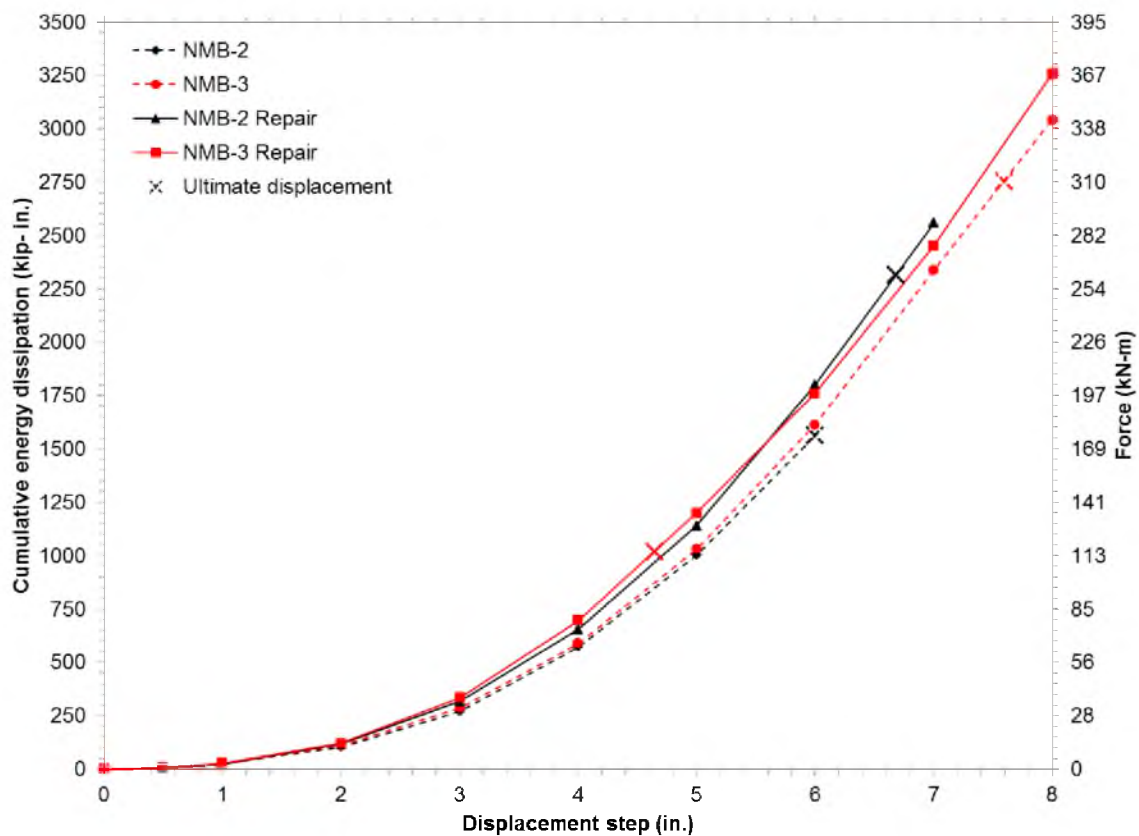
Figure 4.28 – Cumulative energy dissipation capacity of four tests

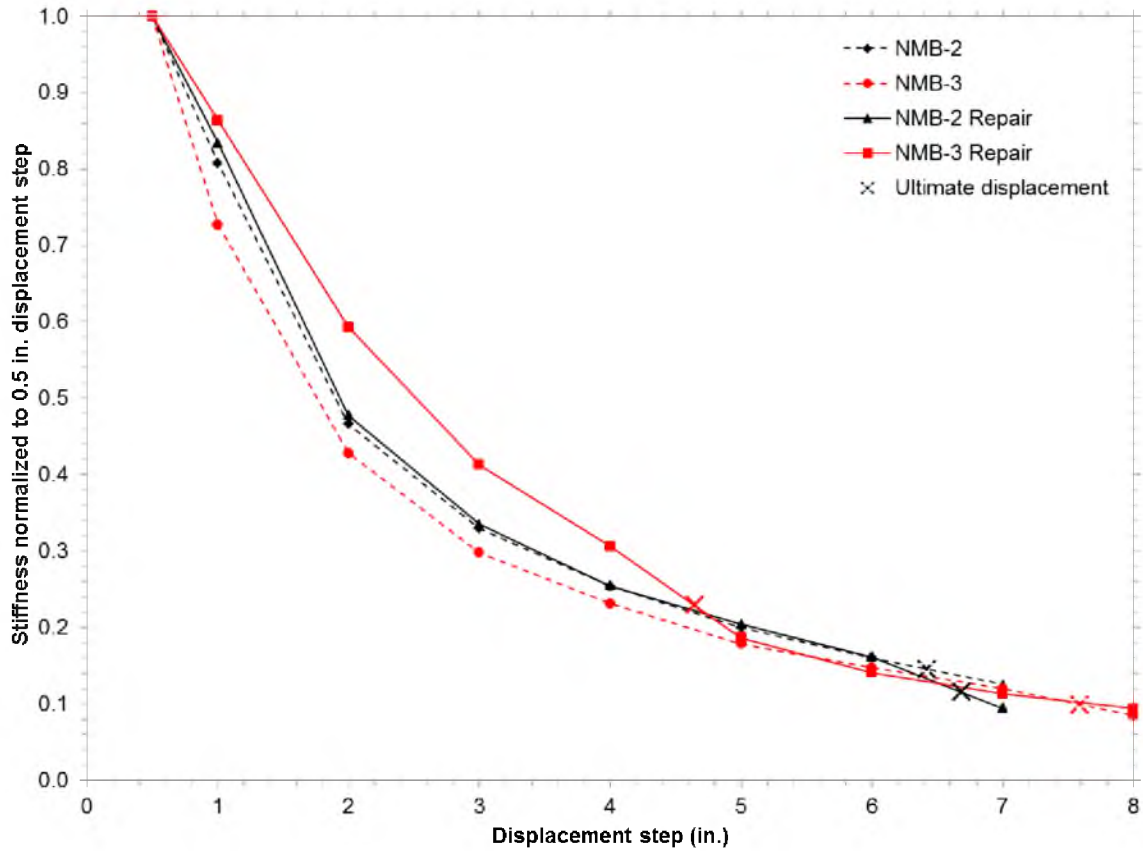
Figure 4.29 – Stiffness degradation of all four tests

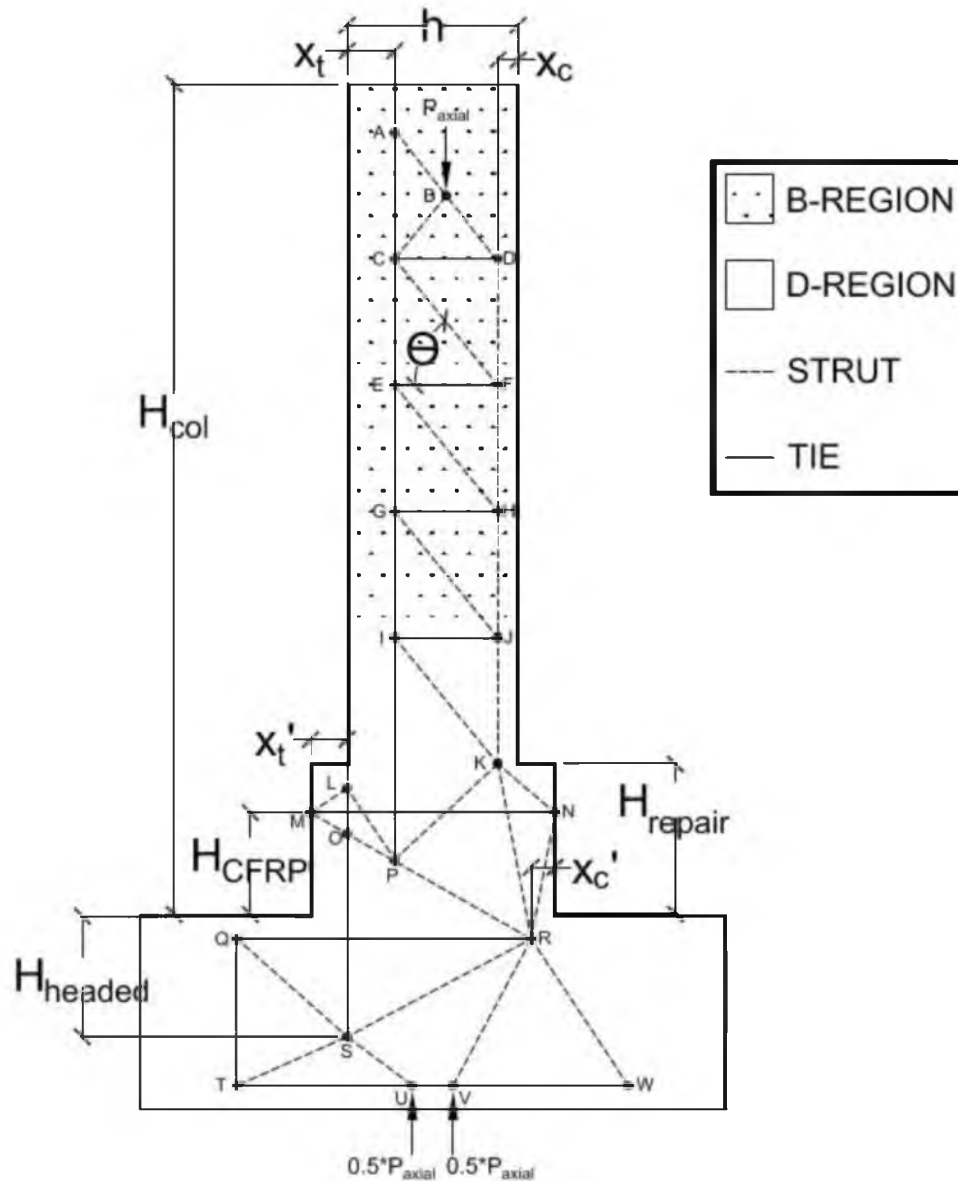
Figure 5.1 – STM layout

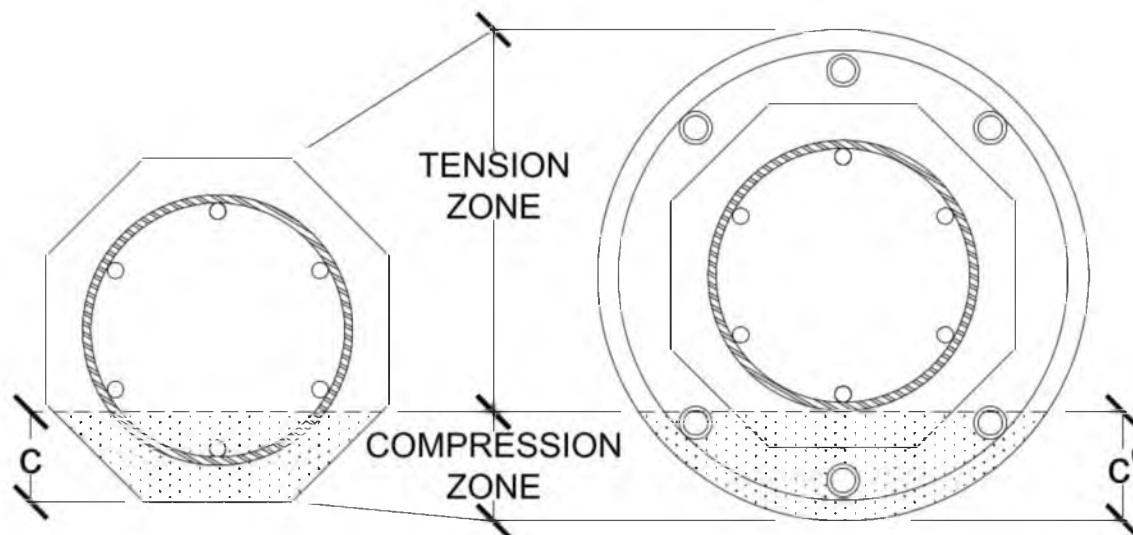
Figure 5.2 – Graphical representation of first yield state

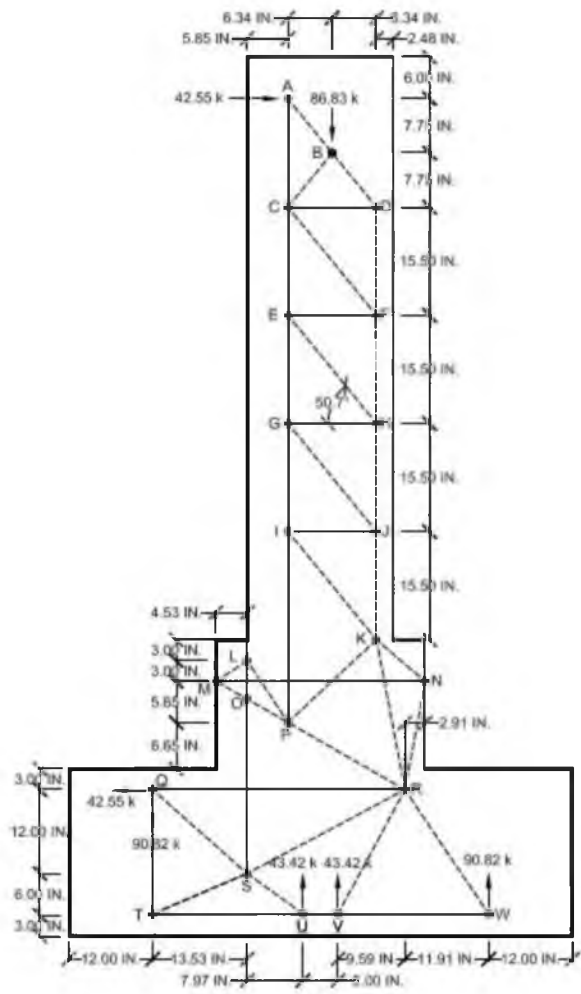
Figure 5.3 – NMB-2 Repair STM dimensions, loading, and reactions

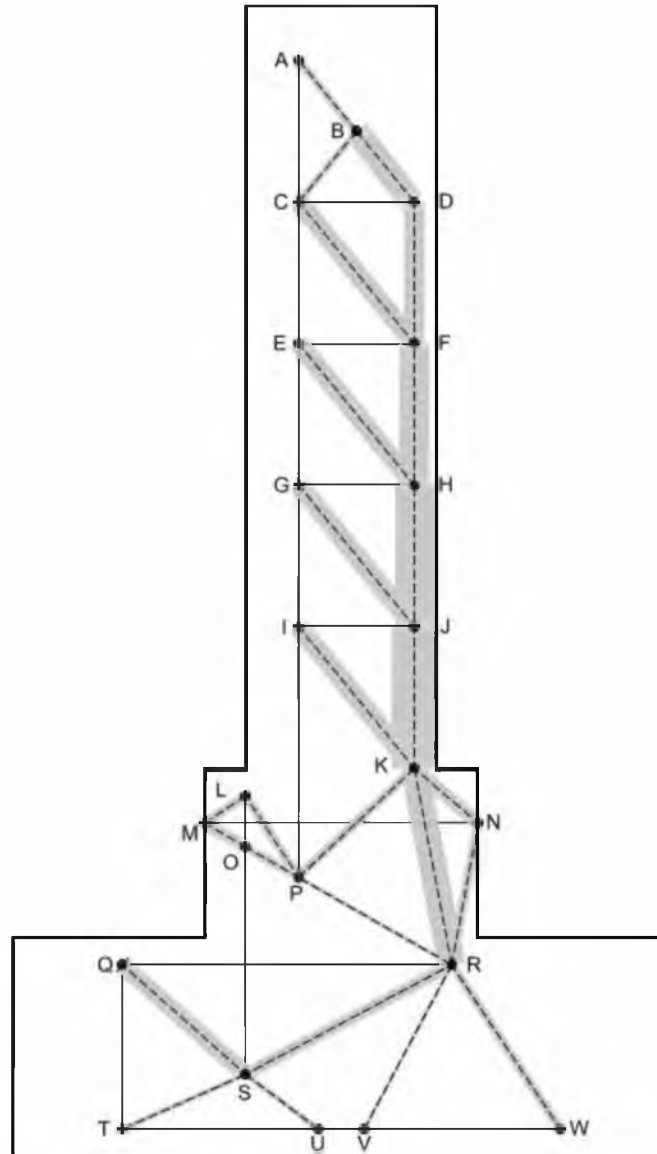
Figure 5.4 – Graphical representation of $A_{cs,min}$ for NMB-2 Repair at a fictitious load crushing JK

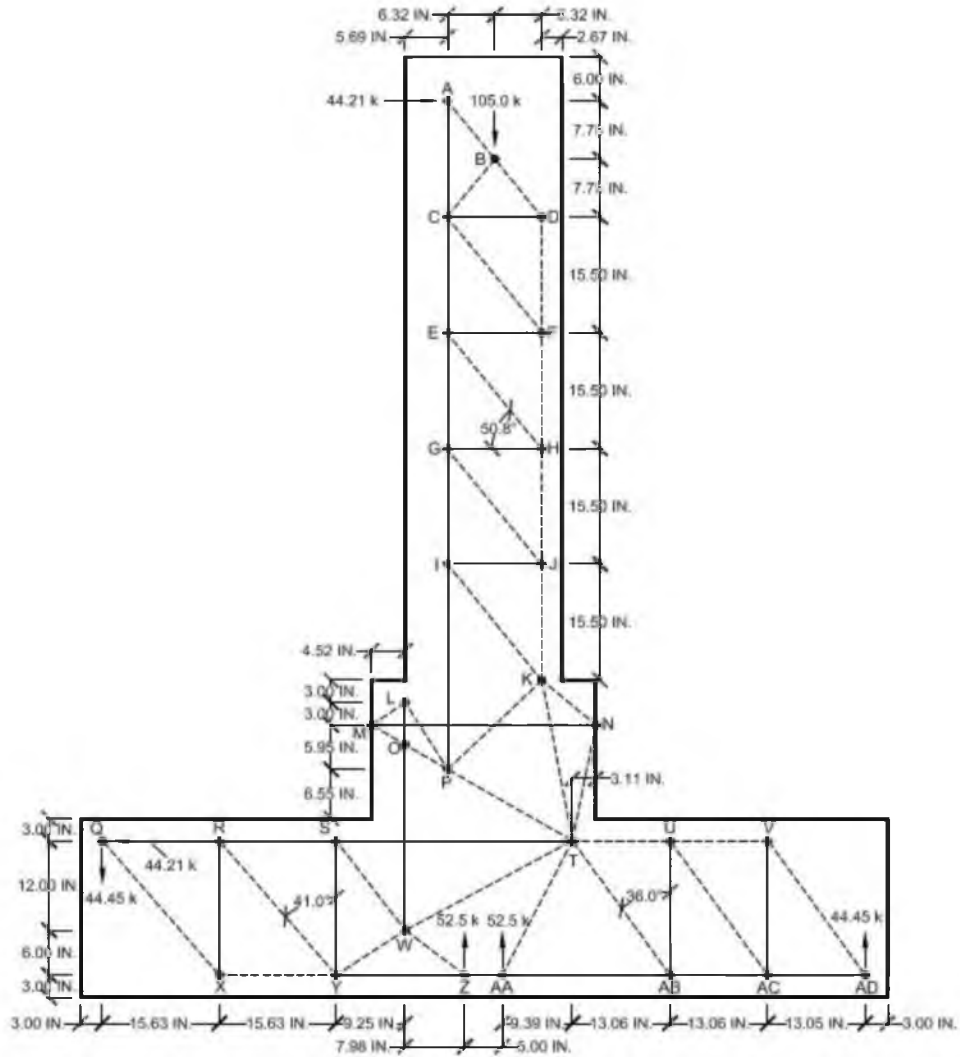
Figure 5.6 – LEN-2 Repair STM dimensions, loading, and reactions

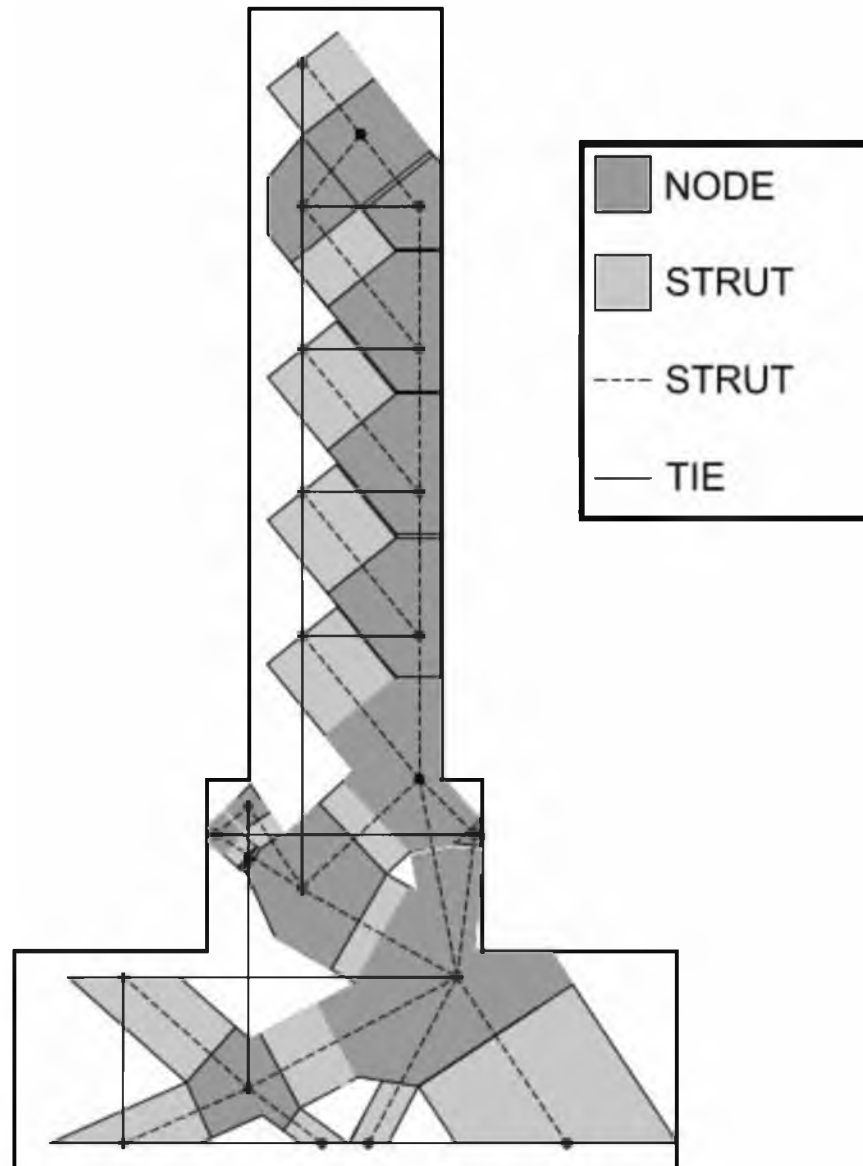
Figure 5.9 – Strut widths used to determine the member areas of NMB-2 Repair

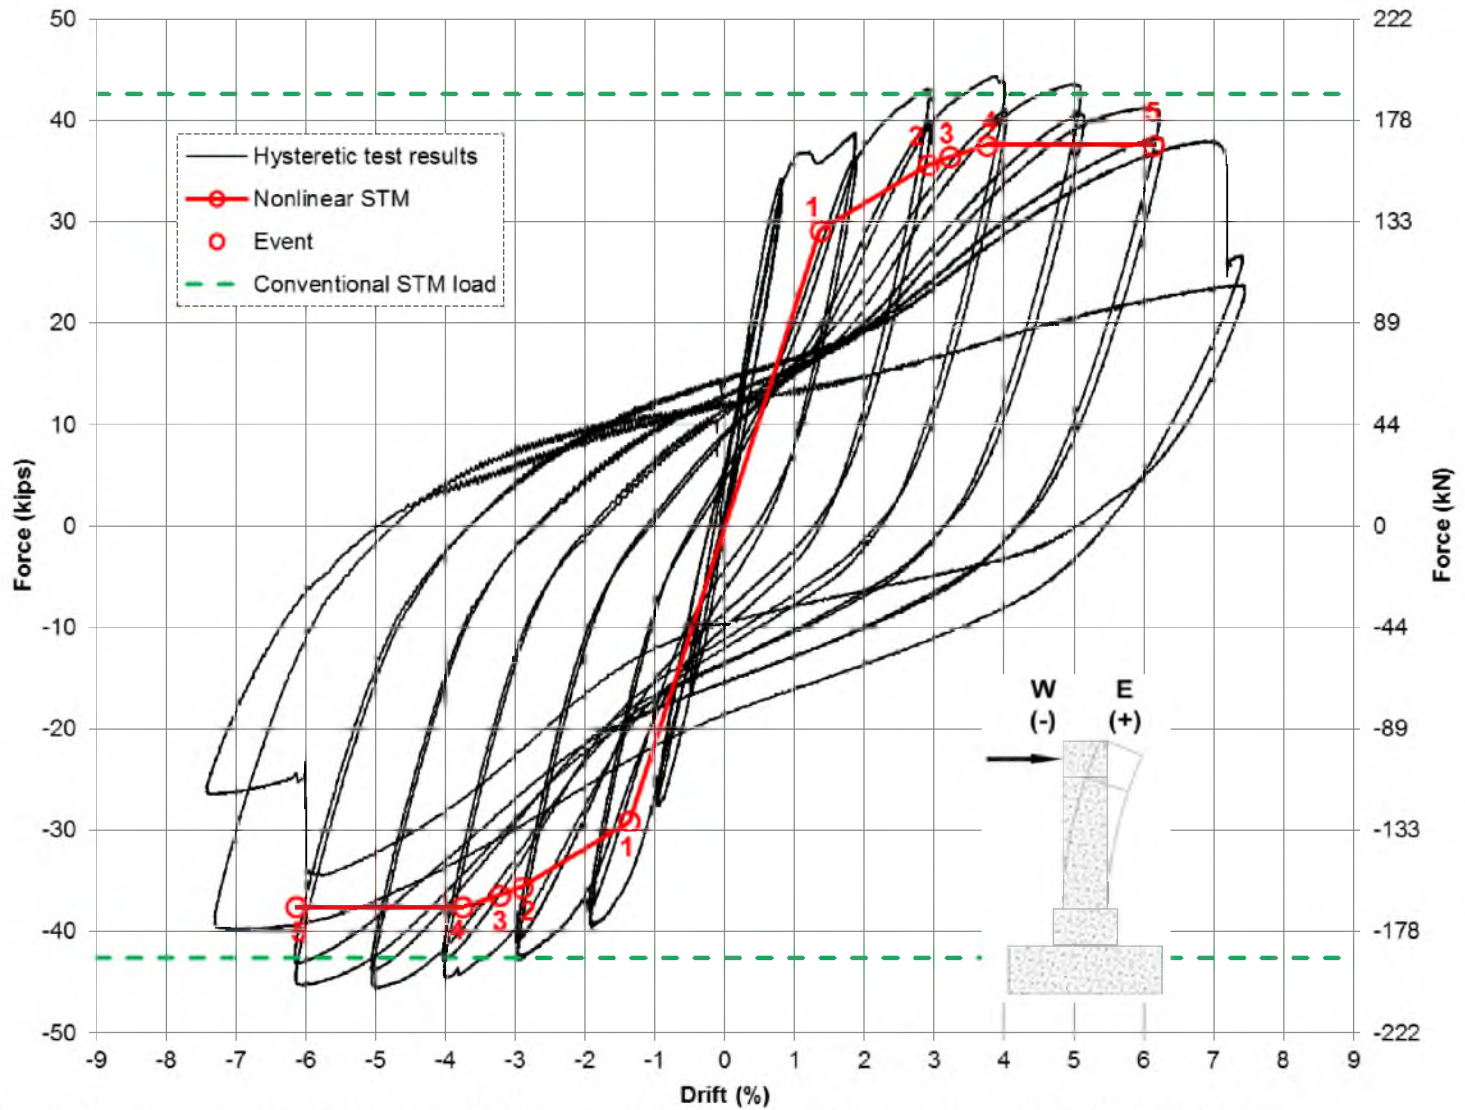
Figure 5.10 – NMB-2 Repair hysteresis, nonlinear STM force-displacement envelope, and conventional STM load results

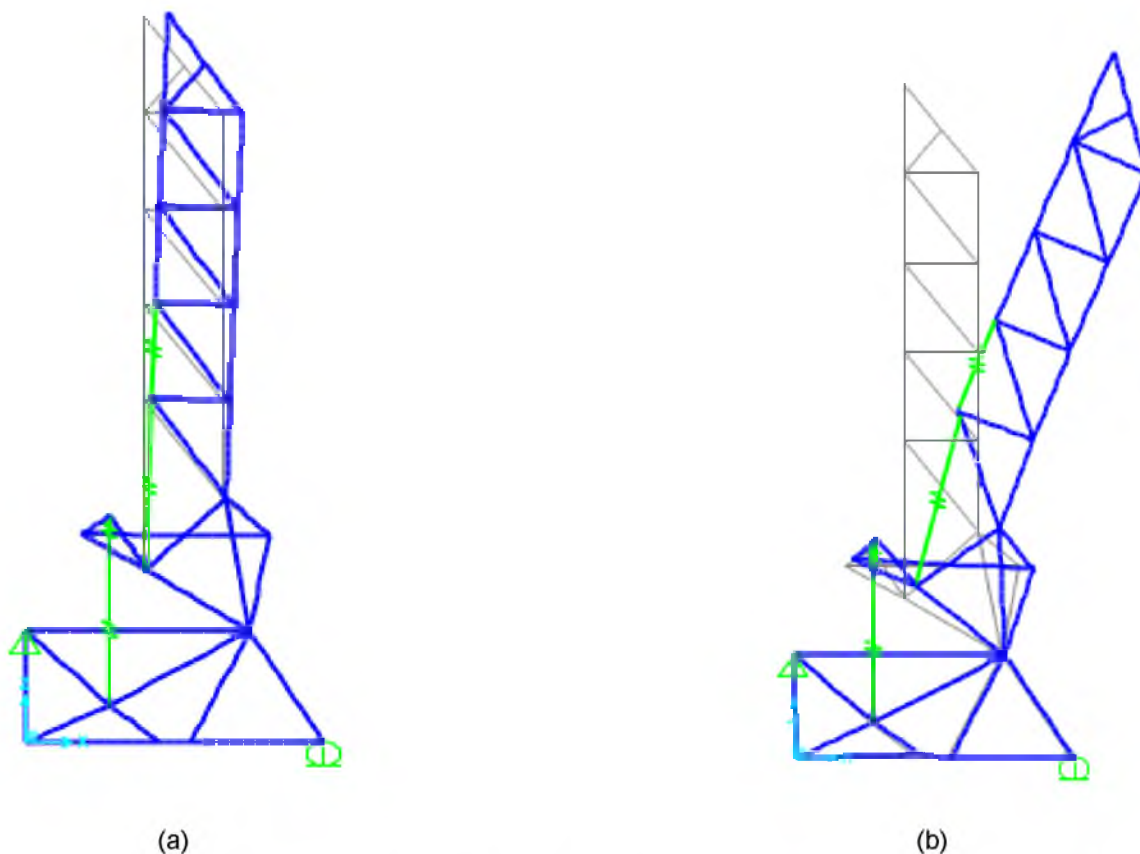
Figure 5.11 – NMB-2 Repair nonlinear STM deflected shape at event 4: (a) 1x scale factor, (b) 10x scale factor

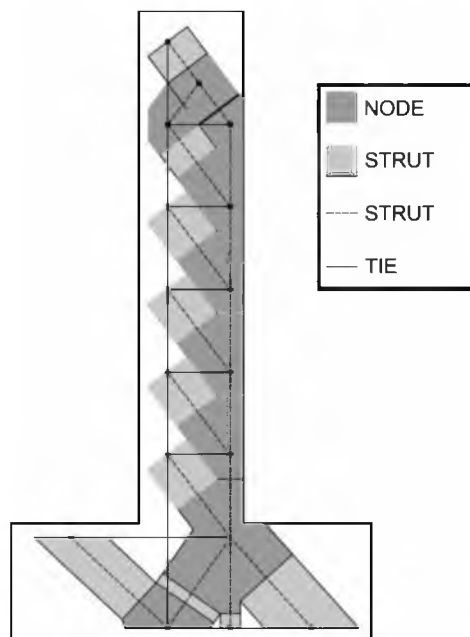
Figure 5.12 – Strut widths used to determine the member areas of NMB-

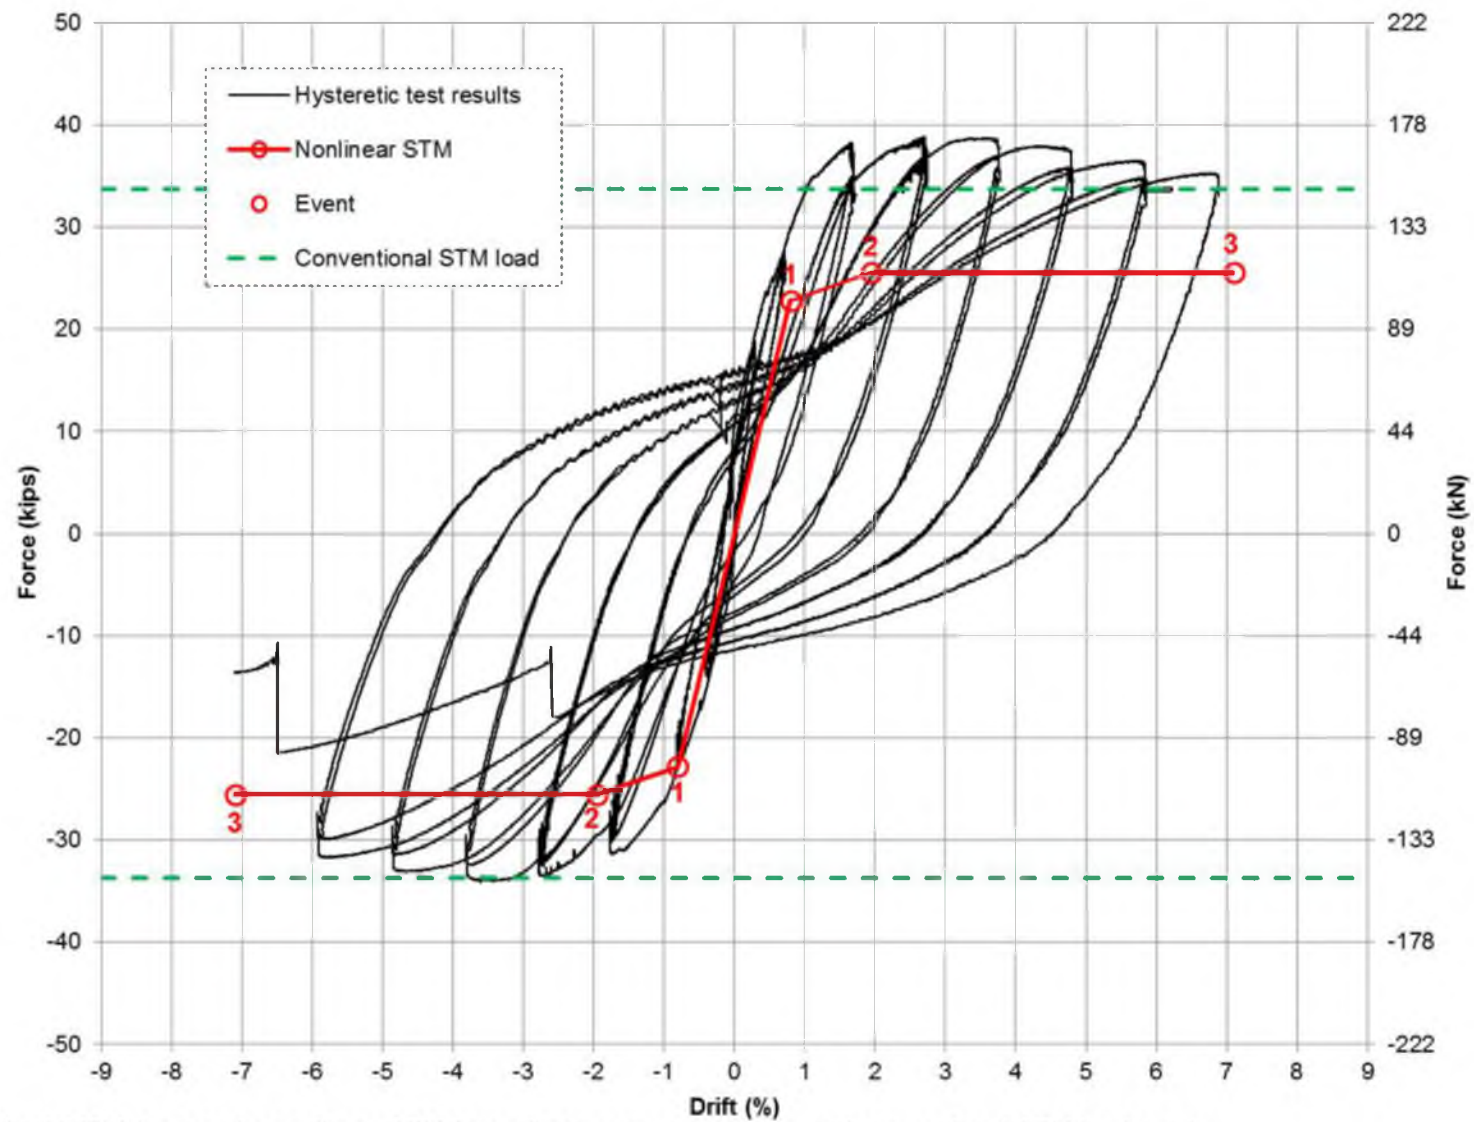
Figure 5.13 – NMB-2 hysteresis, nonlinear STM force-displacement envelope, and conventional STM load result

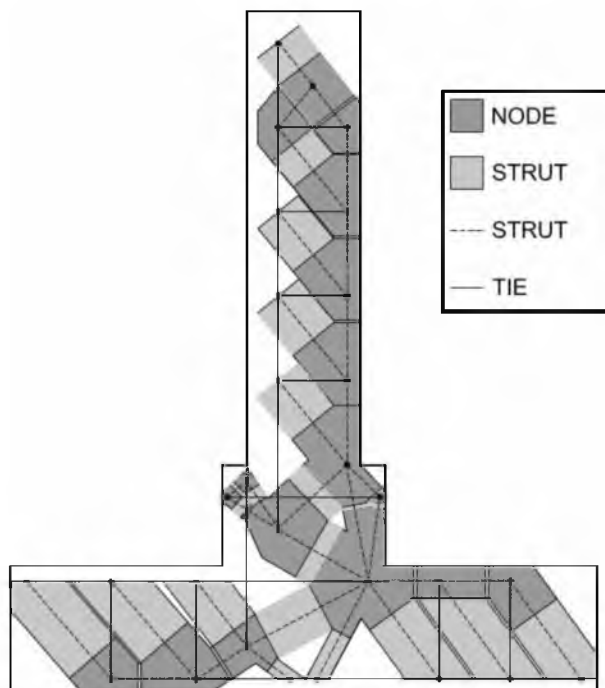
Figure 5.14 – Strut widths used to determine the member areas of LEN-2 Repair

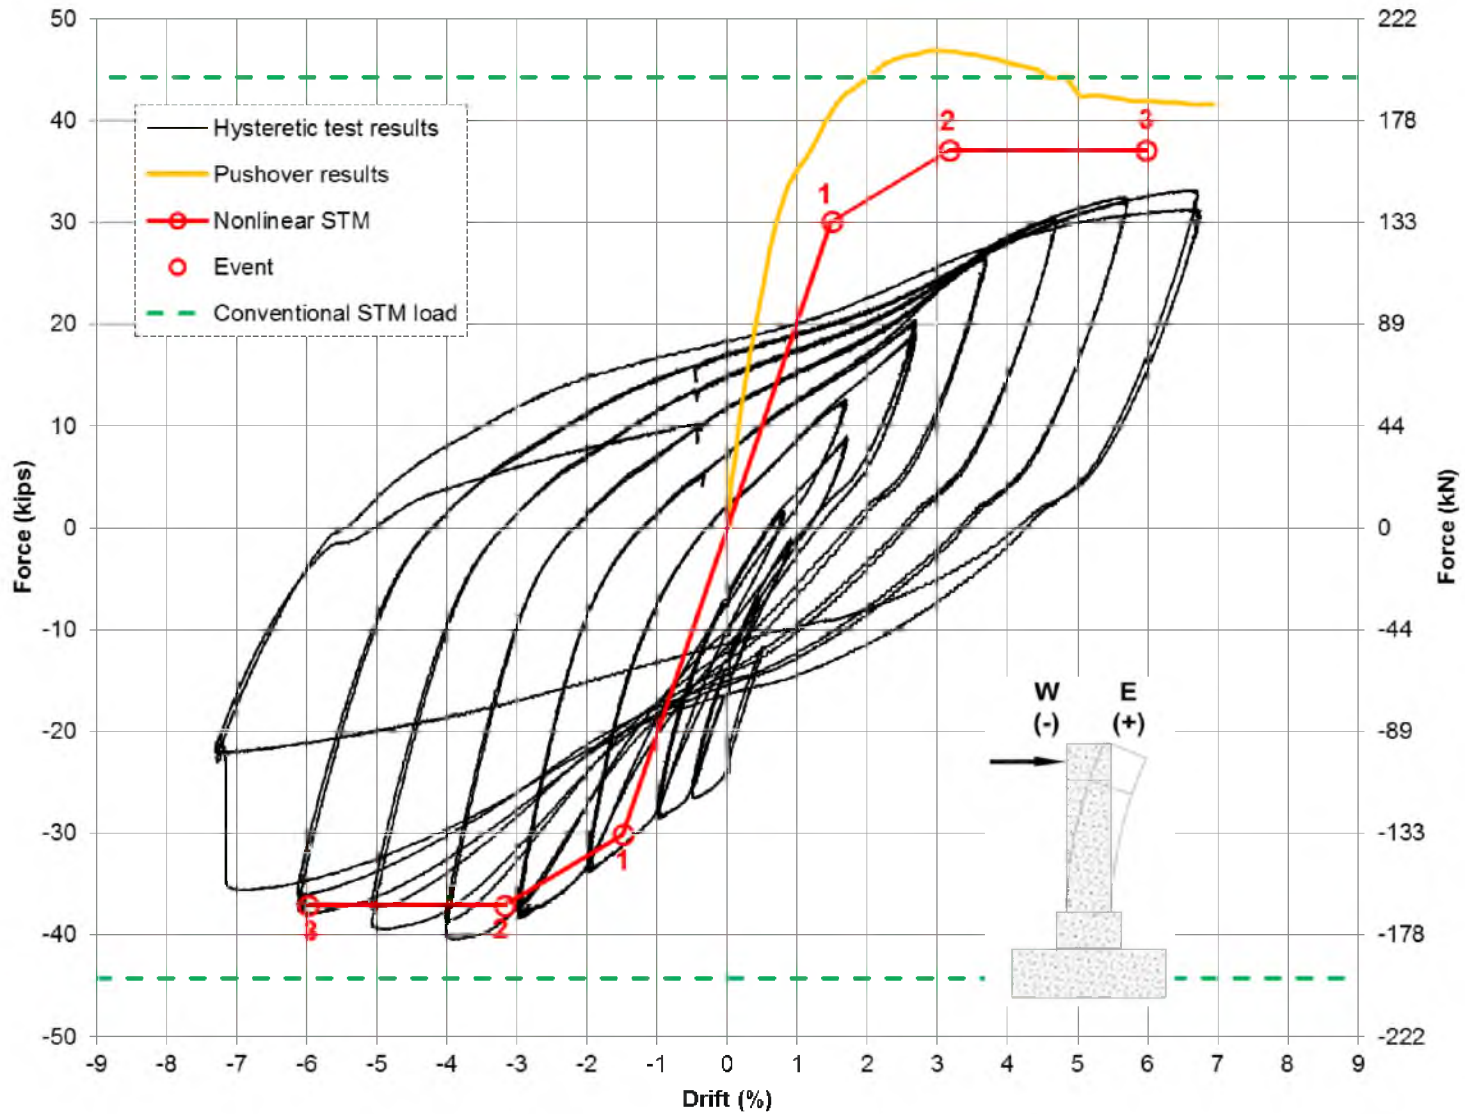
Figure 5.15 – LEN-2 Repair hysteresis, nonlinear STM force-displacement envelope, and conventional STM load result

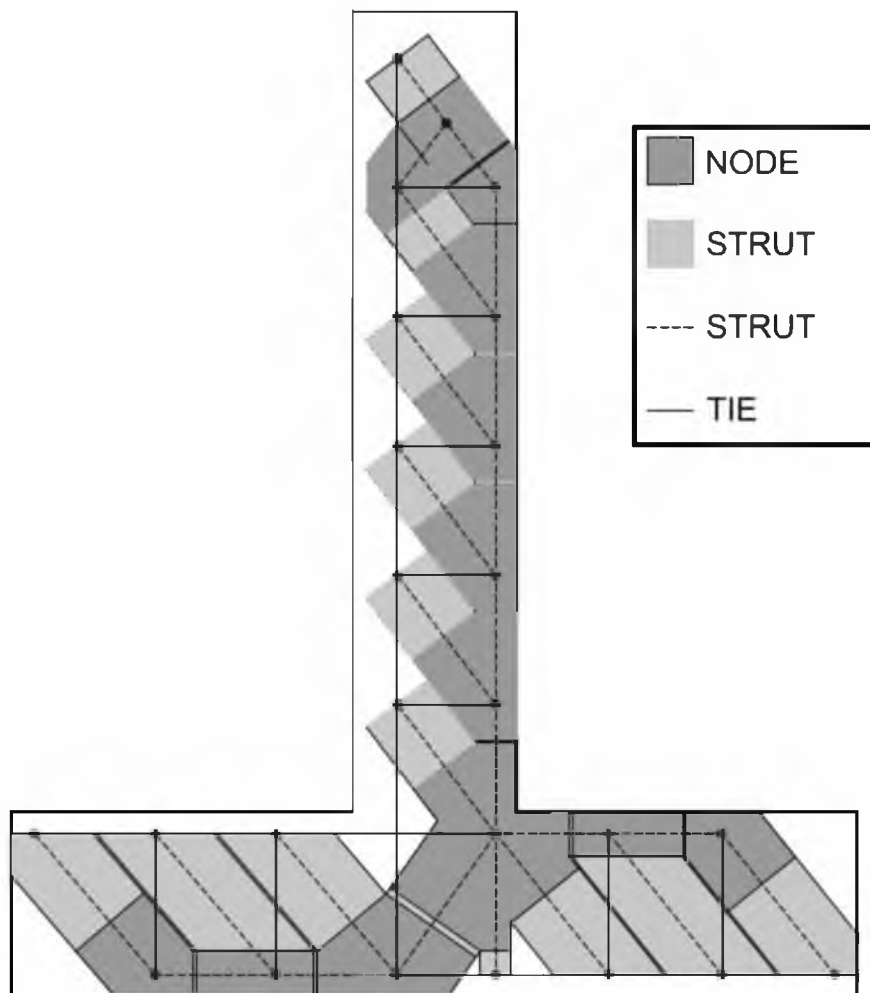
Figure 5.16 – Strut widths used to determine the member areas of LEN-2

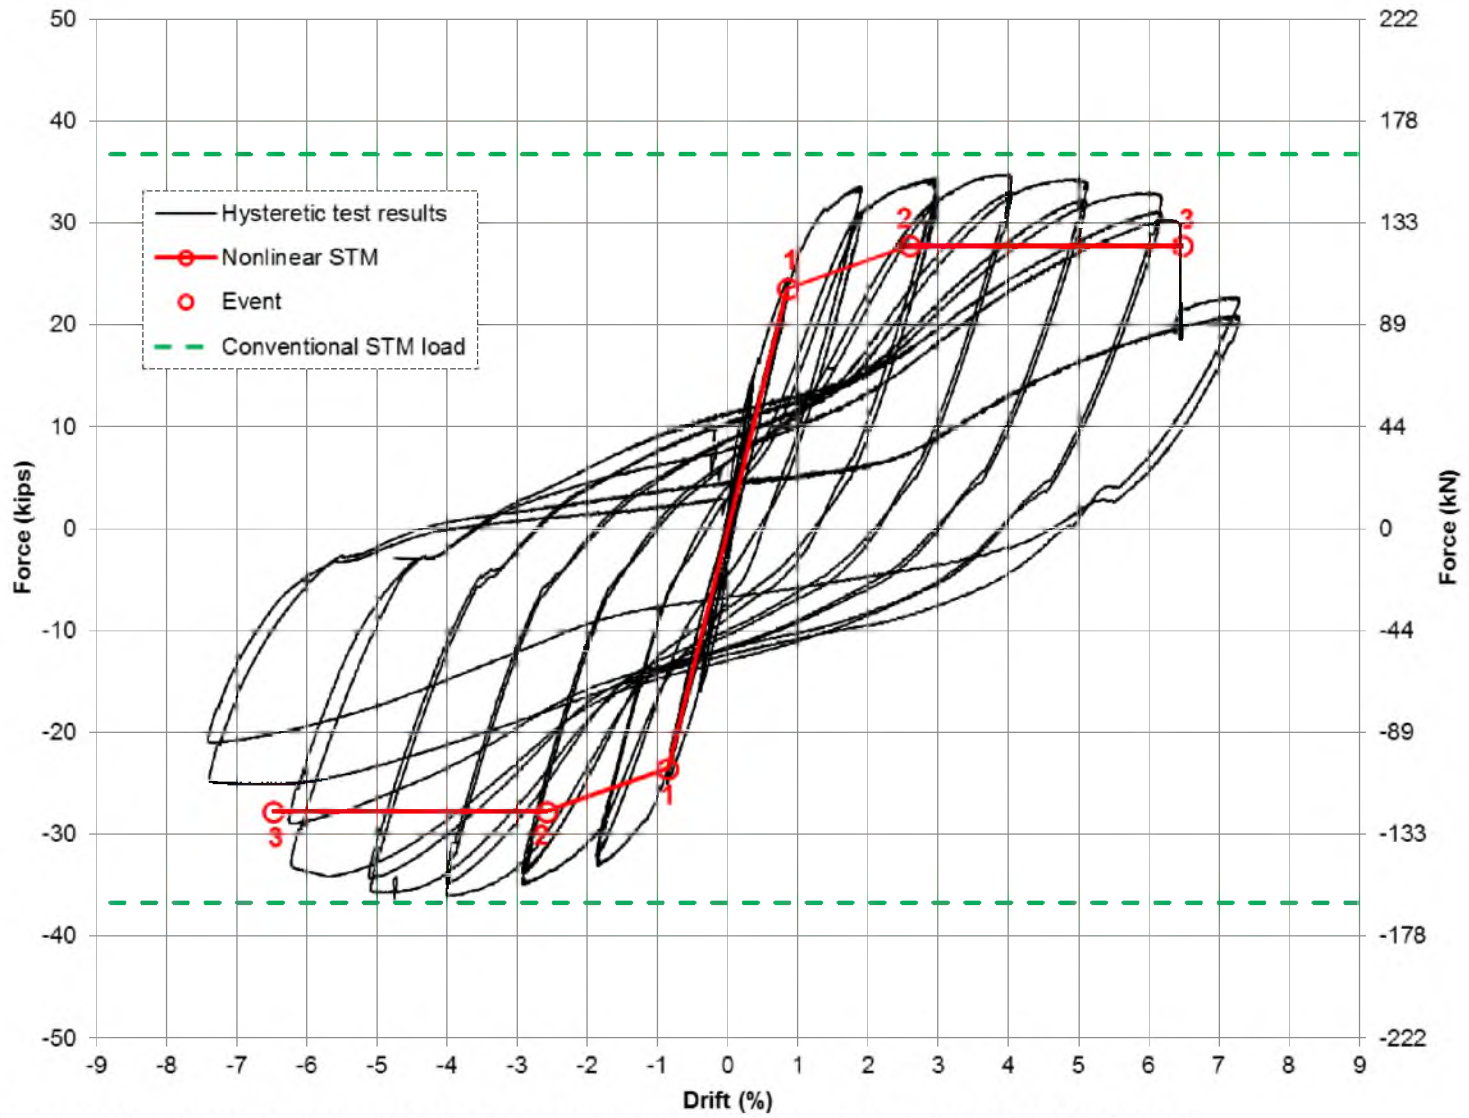
Figure 5.17 – LEN-2 hysteresis, nonlinear STM force-displacement envelope, and conventional STM load result

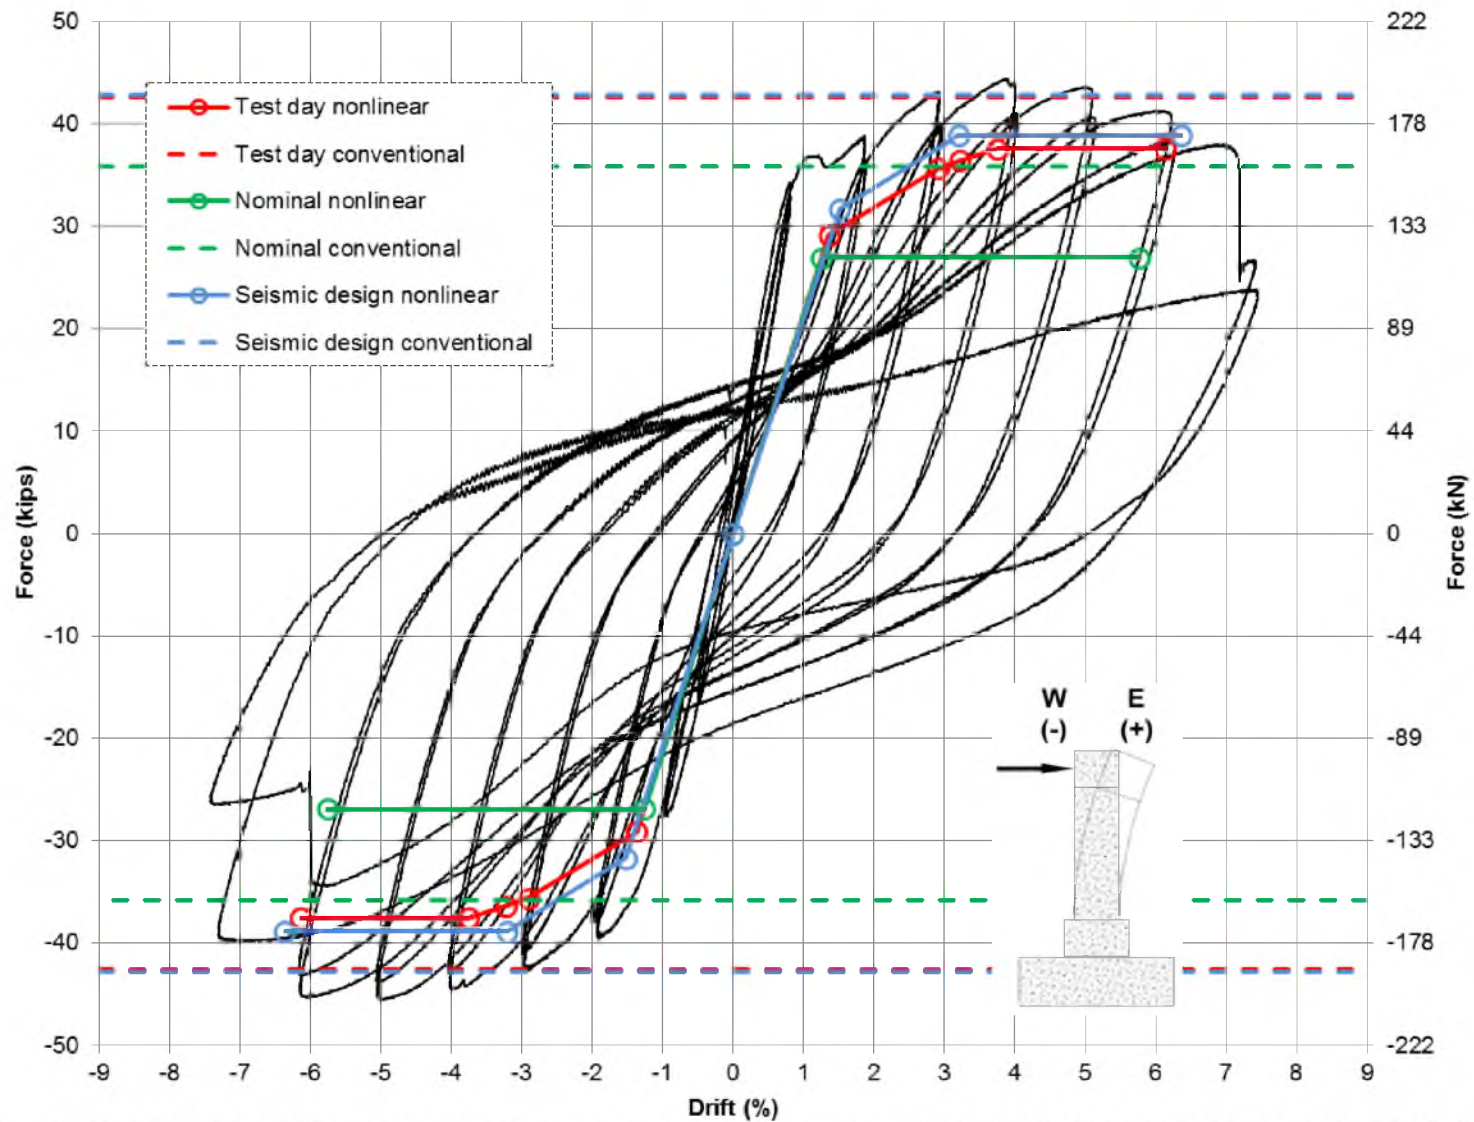
Figure 5.18 – Nonlinear STM force-displacement response envelopes and conventional STM results for NMB-2 Repair parametric study

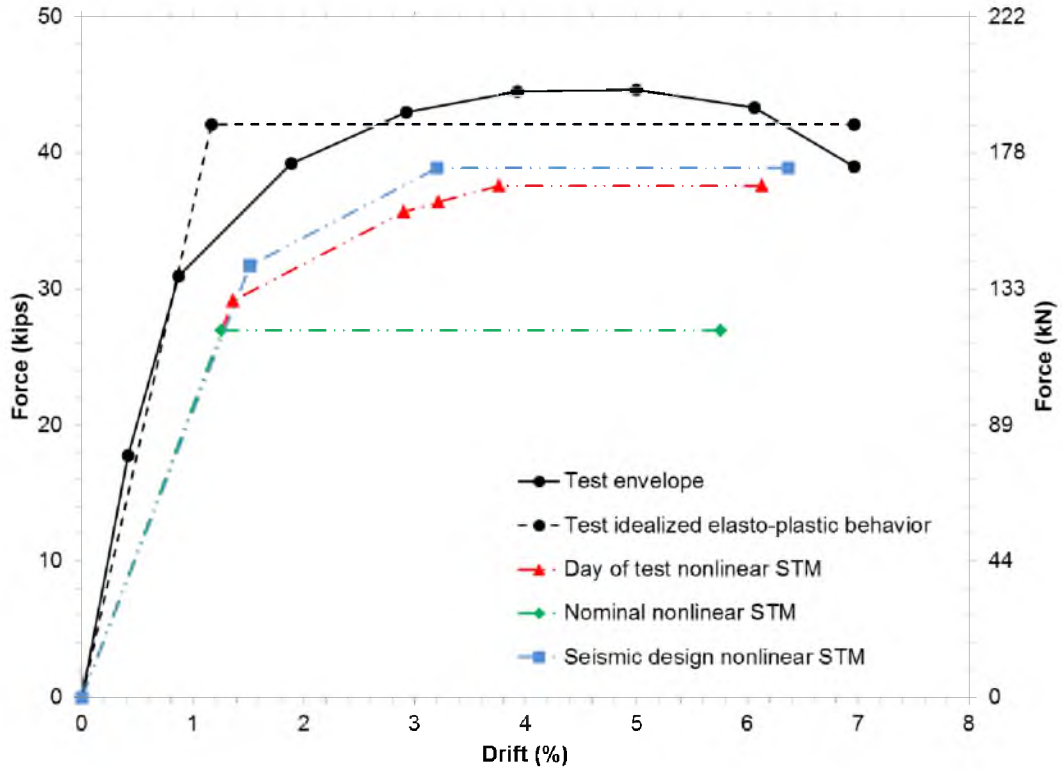
Figure 5.19 – NMB-2 Repair test envelope, elasto-plastic response, and modeling results

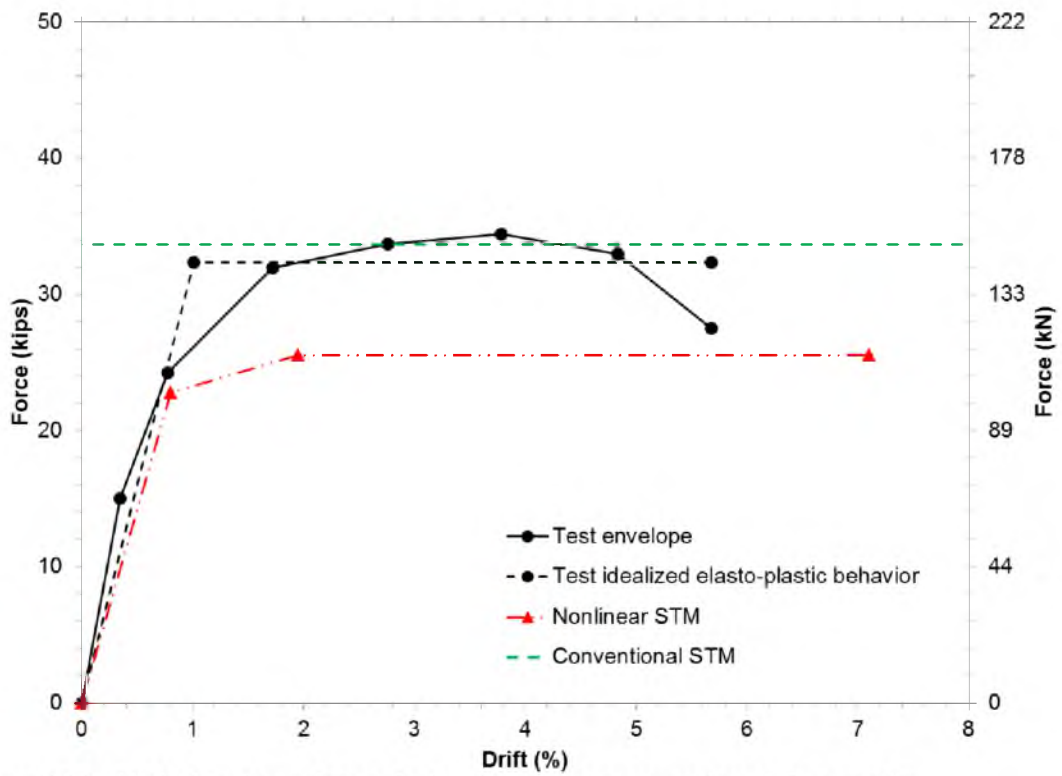
Figure 5.20 - NMB-2 test envelope, elasto-plastic response, and modeling results
