POSTEARTHQUAKE REPAIR OF PRECAST CONCRETE
COLUMN-TO-FOOTING PLASTIC HINGES

Dylan Neil Brown

A thesis submitted to the faculty of
The University of Utah
in partial fulfillment of the requirements for the degree of

August 2014

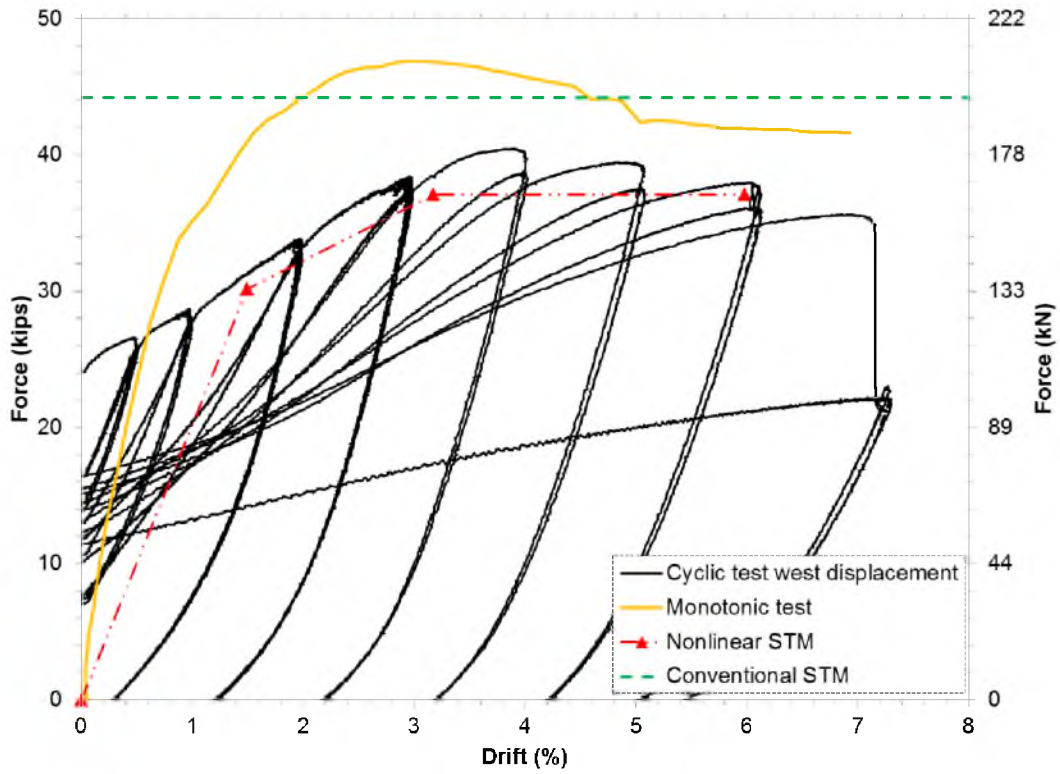
Figure 5.21 - LEN-2 Repair strong side hysteresis, monotonic pushover, and modeling results

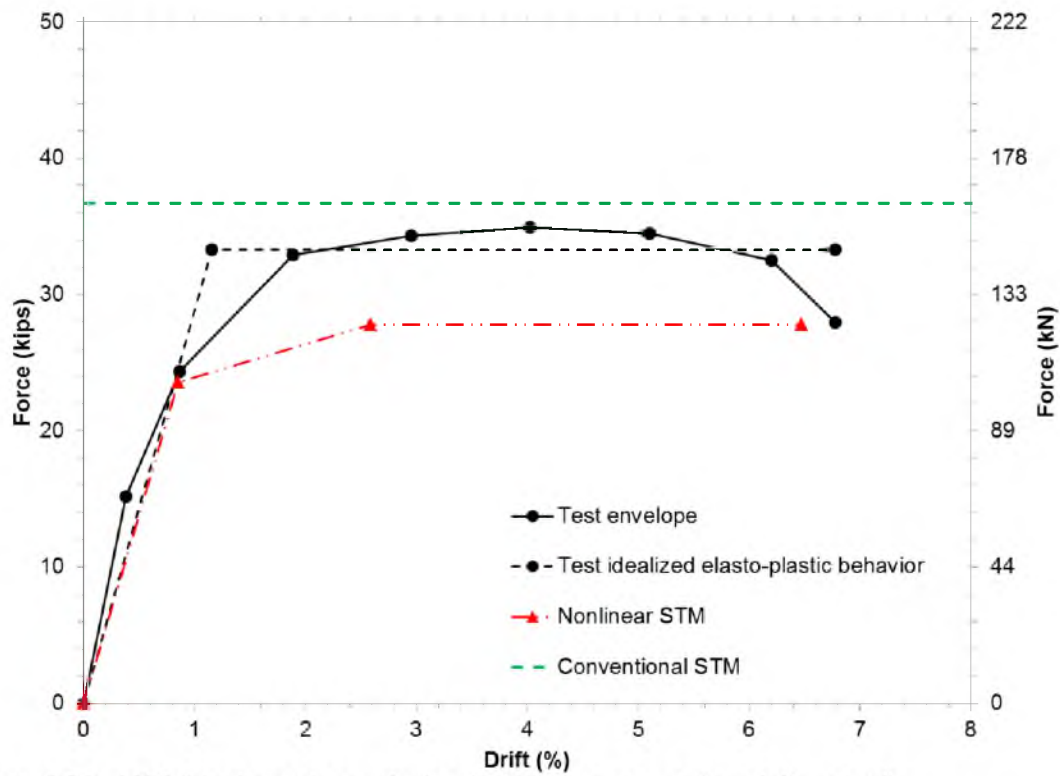
Figure 5.22 - LEN-2 test envelope, elasto-plastic response, and modeling results

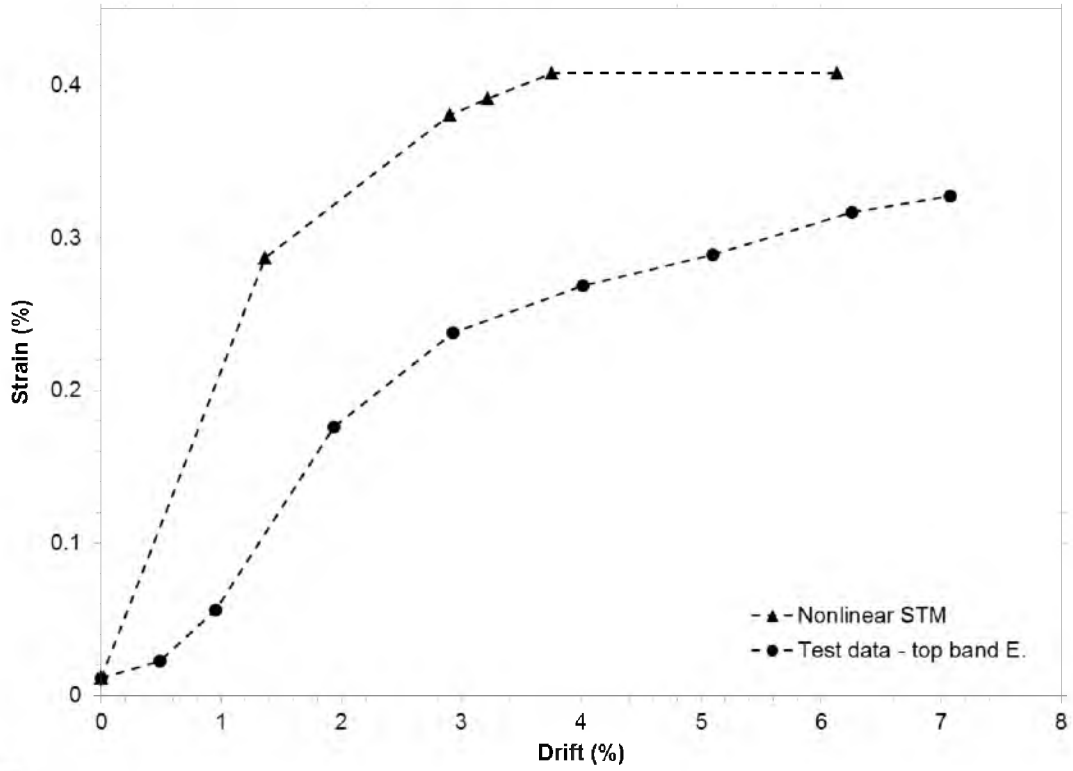
Figure 5.23 – NMB-2 Repair CFRP wrap strain gauge data and nonlinear STM output

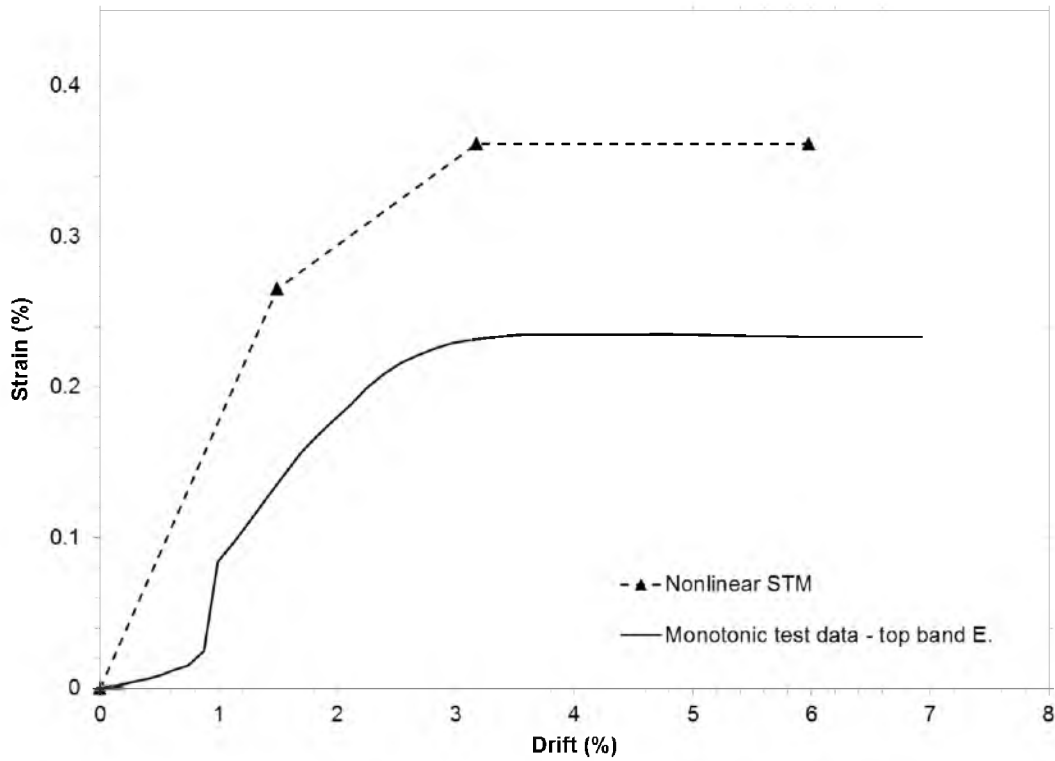
Figure 5.24 – LEN-2 Repair CFRP wrap strain gauge data and nonlinear STM output
